# Pedestrian & Road Safety Audit

McCutcheon HS & Mayflower Mill ES Area

Area Plan Commission of Tippecanoe County

December 2016

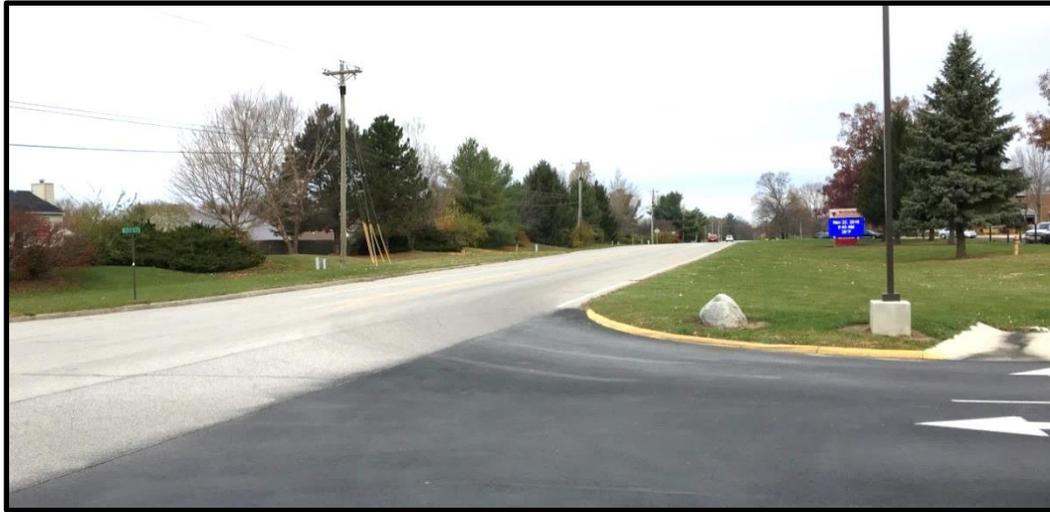
At McCutcheon's south driveway and looking north

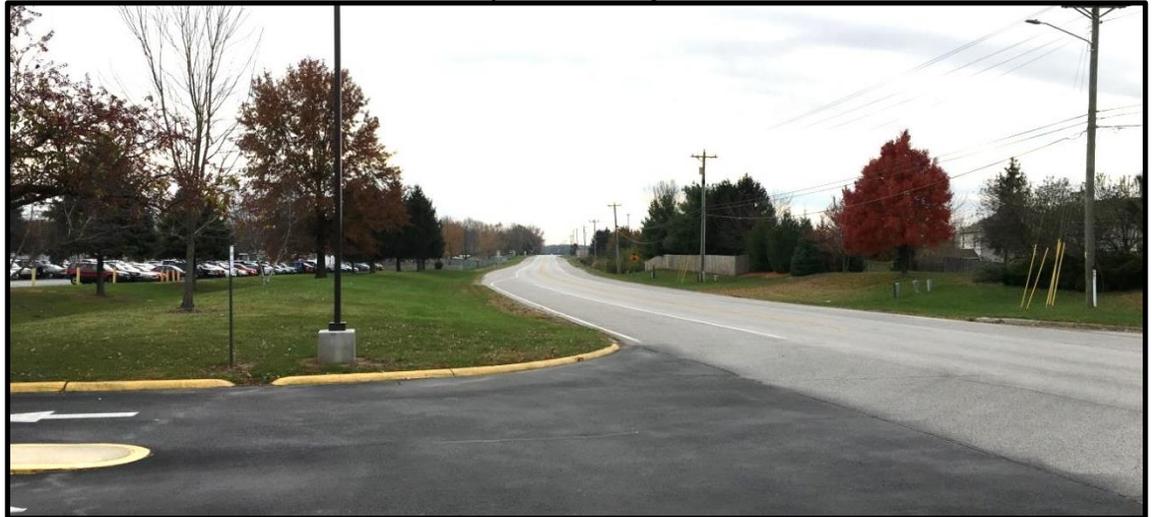
At McCutcheon's south driveway and looking south

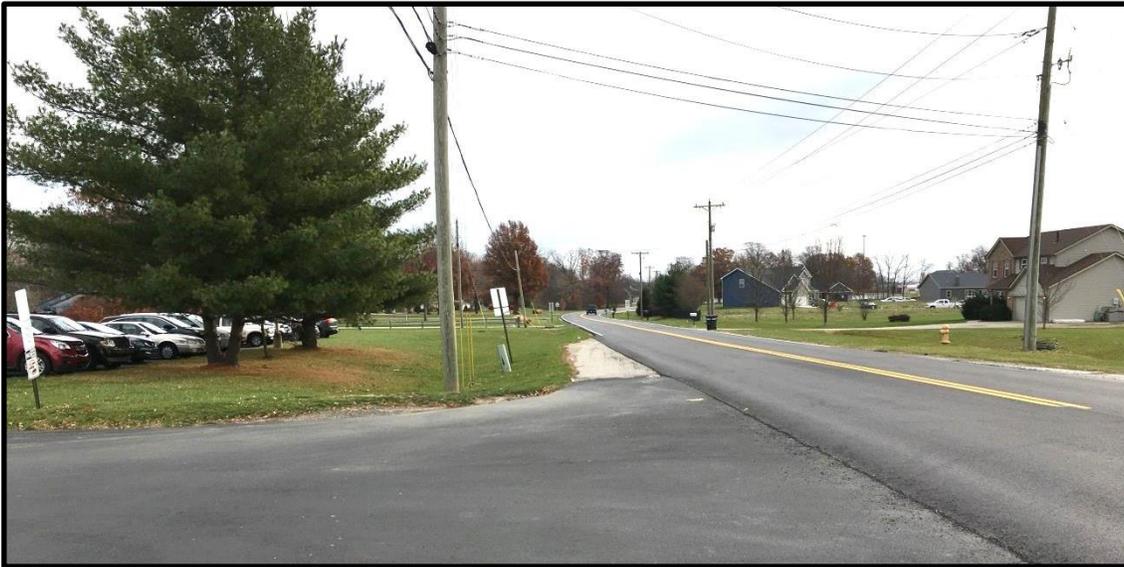
At Mayflower Mill's west driveway and looking east

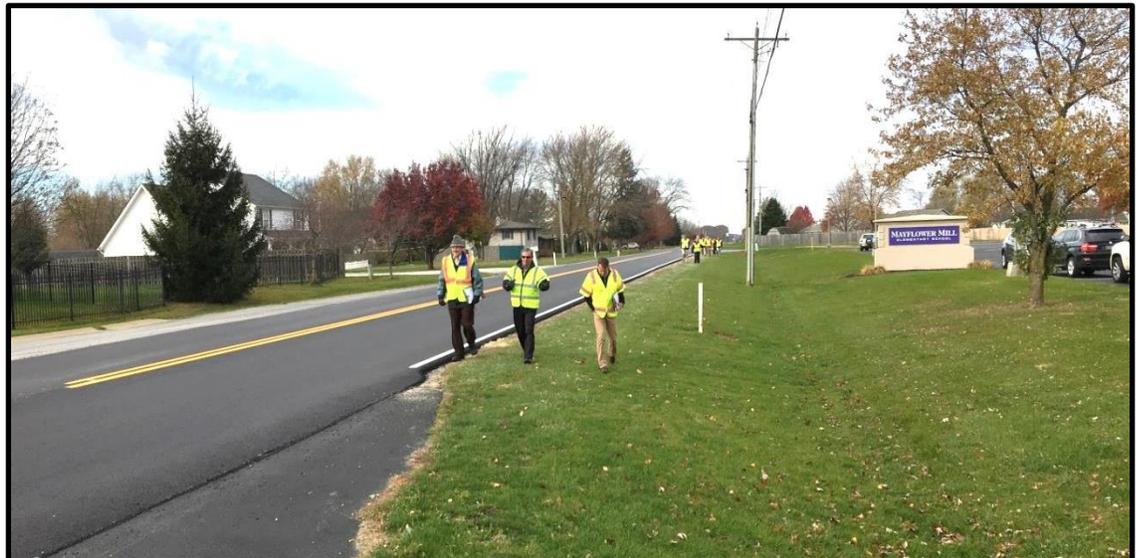
At Mayflower Mill's east driveway and looking west

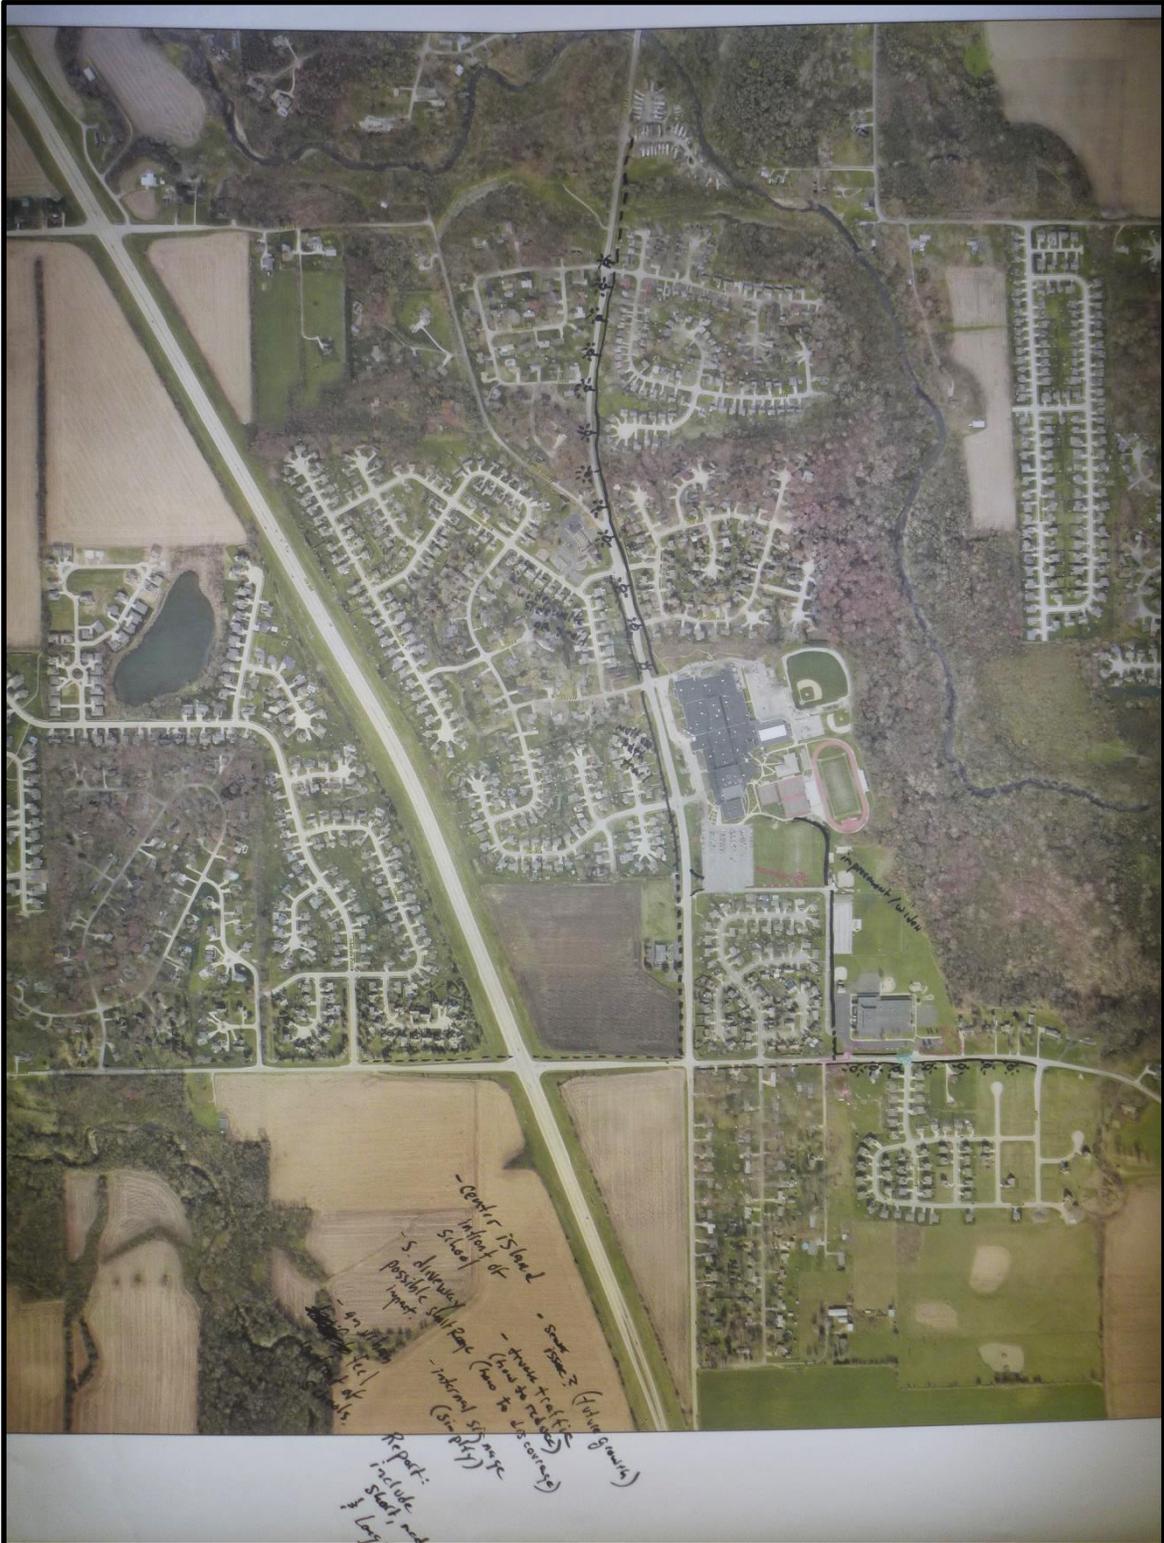
Figure 1

During the discussion, comments and recommendations from the audit team were recorded on large sheets of paper and drawn on two maps (Figure 1 & 2). The following recommendations were made:

- Construct sidewalks/trails
  - New facility from Berwick Drive to CR 500S.
  - New facility from Snowberry Lane to CR 500S.
  - New facility from CR 500S to Admirals Point Drive.
  - Construct sidewalks along the entrance roads of subdivisions on Old US 231 and CR 500S.

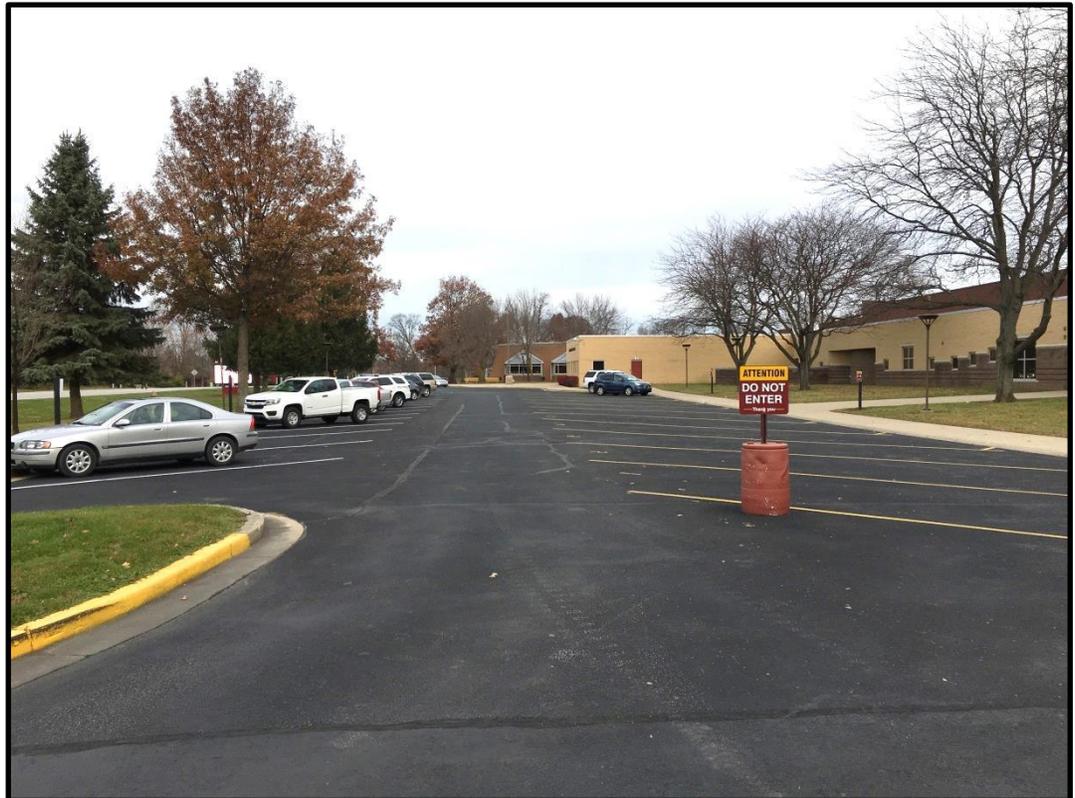
McCutcheon's south driveway looking west

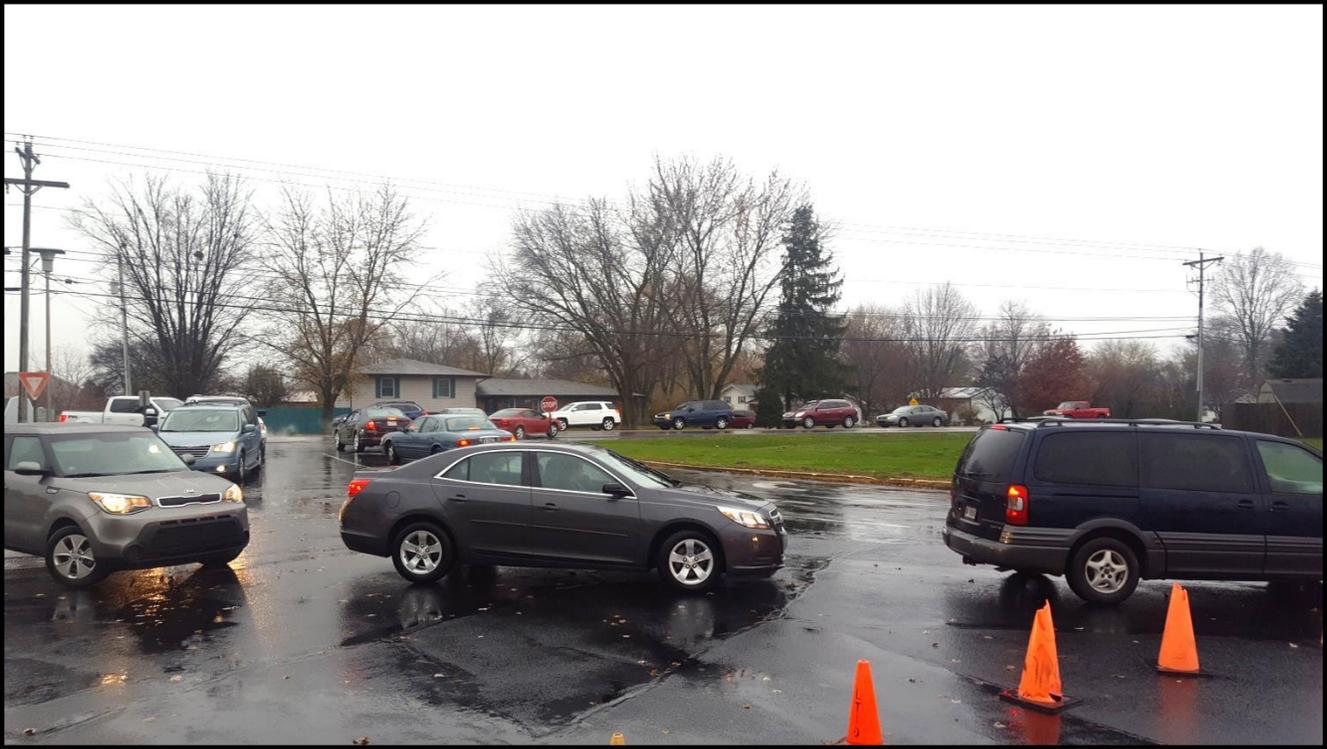
Looking south and west at the number of cars waiting to pick up students

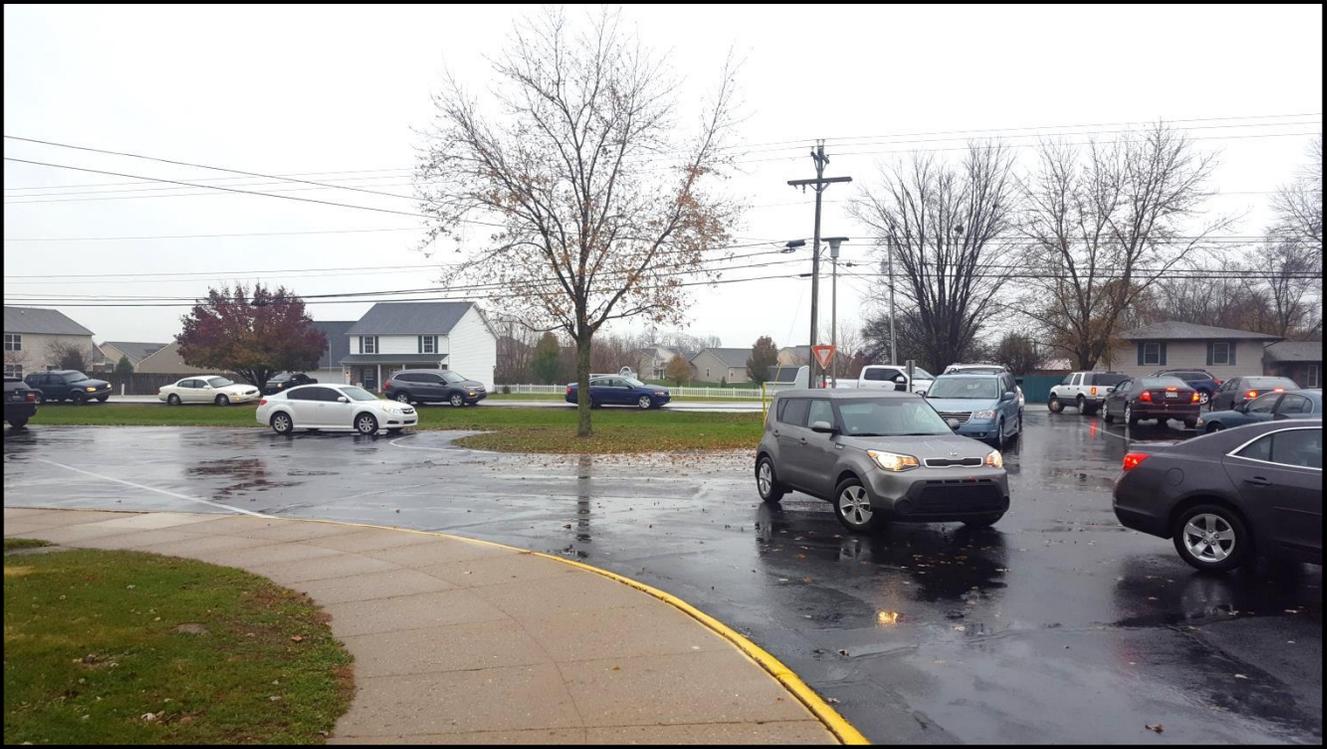
Looking south and east at the number of cars waiting to pick up students
