Heartland Highway Road Safety Audit

*A report detailing a road safety audit of
State Road 25 from Lafayette to
Logansport, Indiana*

August 2000

Delphi Systems Inc.

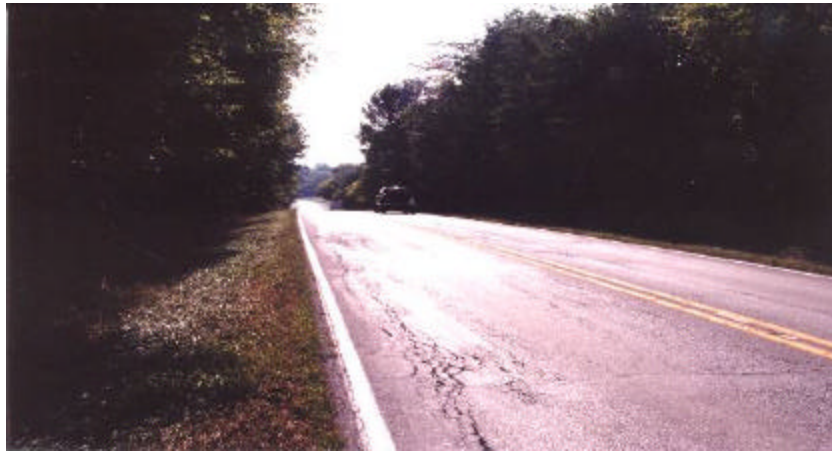
2. Shoulder widths throughout the study area are virtually zero, leaving no room for maneuvering in the event of emergencies, recovery from an excursion from the traveled way, stopping because of breakdown, or even police enforcement activities.

Shoulders play an important part in providing the user with such opportunities, and also influence driver behavior on the road itself. The absence of shoulders may tend to encourage drivers to place their vehicles closer to the centerline than might otherwise be the case – thus increasing the possibilities of sideswipes and/or head-on collisions between opposing vehicular traffic. During the course of the audit, the aftermath of at least one collision of this type was observed.

Figure 1, is illustrative of the typical shoulder availability on SR25.

Figure 1: Lack of shoulder in the cross-section

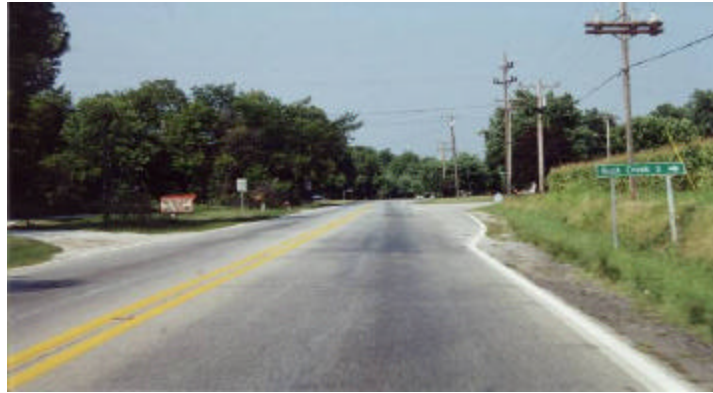
3. Pavement markings play an important role in communicating lane use information to drivers. None of the auxiliary turning or bypass lanes noted above possesses any pavement marking or signing information to help communicate to drivers how they are to be used. Lack of such information can lead to confusion – particularly for drivers unfamiliar with this road. Such ambiguities in signing and marking can have particularly negative consequences when associated with high inter-vehicle speed differentials (stopped and turning vehicles vs. normal through-lane traffic speeds). The potential for collisions will generally increase under such circumstances.

3. The lack of any warning/information signing or pavement markings at intersection left turn bypasses and right turn lanes. Signing and supplementary directional pavement markings play an important role for drivers – especially those who are not necessarily familiar with the route and/or any unusual design features. We found no evidence of measures taken to provide such positive guidance to road users. The lack of good positive guidance leaves motorists in an ambiguous position, and increases the likelihood of collisions in situations where driver workload is already high, such as that which occurs on intersection approaches.

Figure 2: Lack of pavement markings or signing with auxiliary lanes

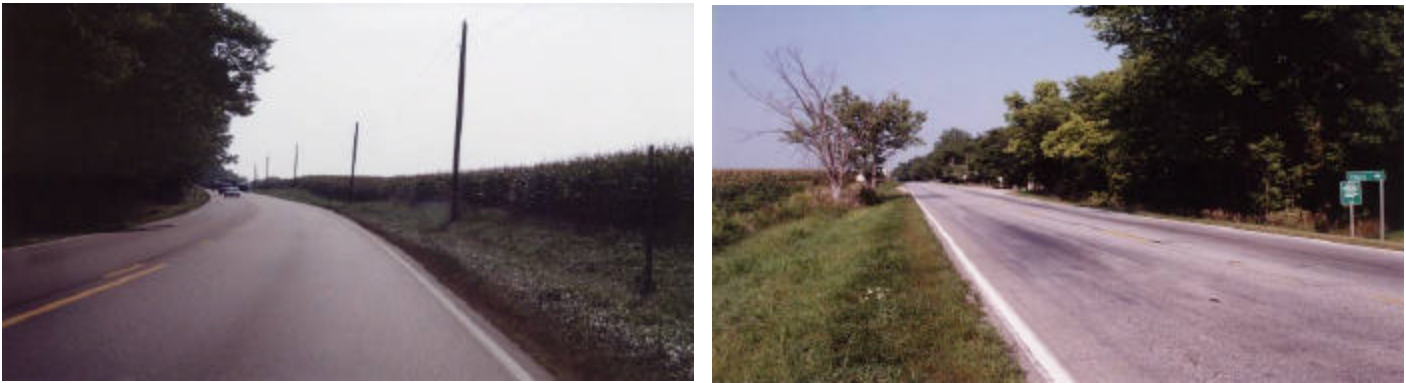
1. It is clear from our review that the kind of clear zone we would normally expect to see on a facility of this type, carrying these volumes of traffic, is not provided anywhere along its length.

Numerous instances of utility pole lines, trees, retaining walls, culvert headwalls, and other roadside "furniture" were noted throughout the study area. These have very serious negative implications for both the frequency and severity of collisions occurring in the study area and merit early attention. Two examples of such problems are provided in Figure 3 on the page following.

Figure 3: Typical roadside obstacle: Utility Poles and Trees

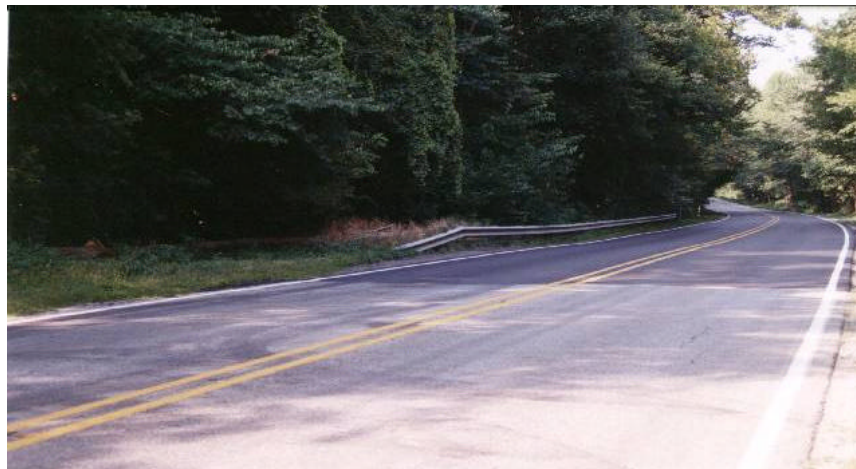
2. Multiple instances of inappropriate traffic barrier installations were noted throughout the project. Among the problems found were: incorrect mounting height and lateral placement; obsolete barrier technology; and the use of outdated barrier terminations. Once again, these problems can reduce the effectiveness of the barrier installations and increase collision frequencies and severities. One example of such barrier related problems is shown in the photograph in Figure 4.

Figure 4: Example of one roadside barrier installation problem: Outdated terminal

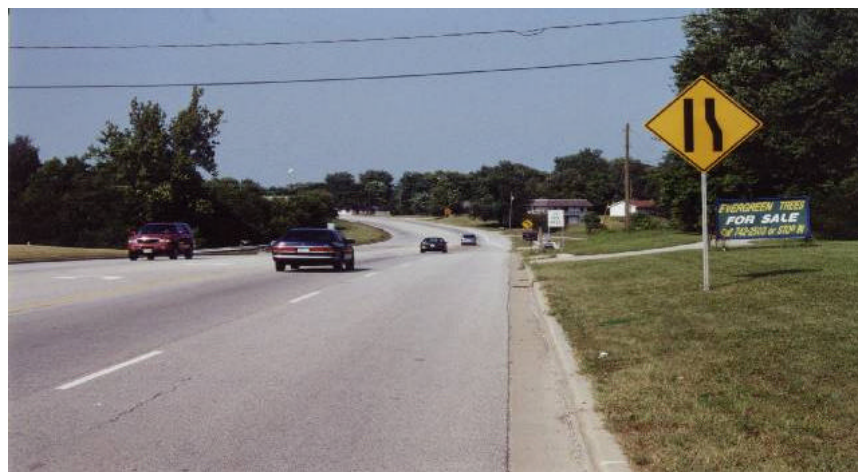
Figure 5: Transition from four lanes to two leaving Lafayette

- After the transition from four lanes to two lanes, (accomplished between mile 0.3 and mile 0.6 in the northbound direction), there are few if any shoulders throughout the section. See Chapter 4 for a discussion of the implications of this fact.

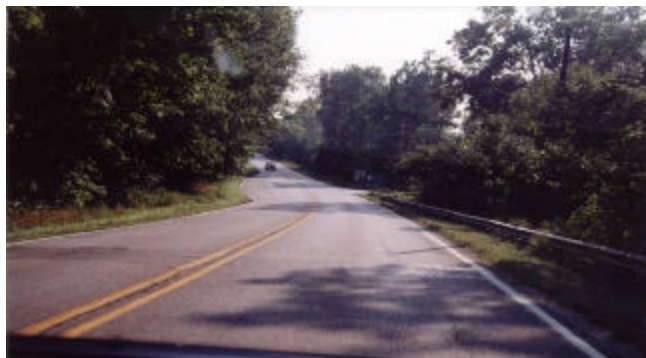
- Law enforcement officers identified the junction of SR25 and State Road 225 (SR225) as an area of particular concern. Our review showed that this intersection is located in the sag of a vertical curve, with substantive grades on the approaches, apparent sight distance restrictions at the approach crests, and horizontal curves on both approaches. No right turn auxiliary lane is provided on SR25. Turning radii do not permit southbound heavy articulated vehicles to maneuver from SR25 to SR225 without intruding into the opposite direction approach lanes on SR225. The approach grades on SR225 are substantial. This combination of critical factors creates a uniquely hazardous location on SR25 at this intersection.

Figure 6: Intersection of SR25 and SR225: Southbound approach

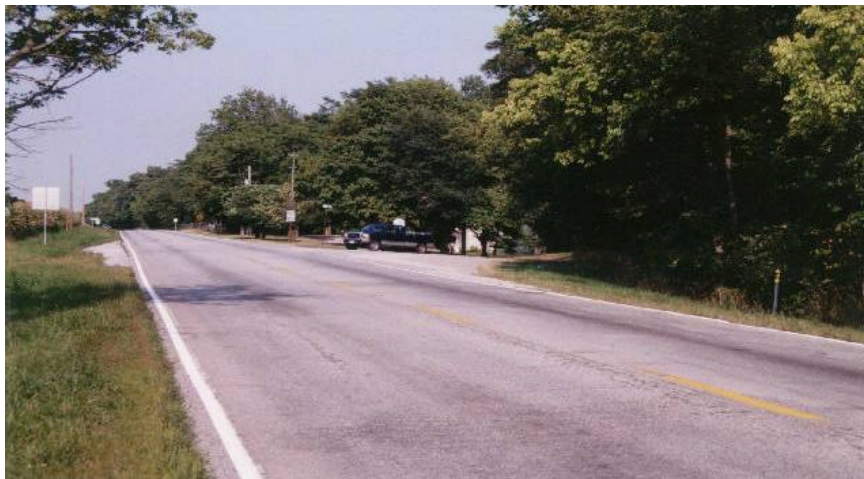
- The intersection of SR25 and County Road 900N marks the end of this section. This intersection is severely oblique, with steep approach grades on County Road 900N. Although it is a major turning point – providing access to the Delphi Municipal Airport and the community of Flora - no provision has been made for appropriate auxiliary turning lanes. Vegetation in the immediate area of the intersection appears to create some sight distance issues.

Figure 7: Intersection of SR25 and County Road 900N
