# Town of Battle Ground Sidewalk Condition Survey

# Town of Battle Ground

## Tippecanoe County, Indiana

*Sidewalk Condition Survey*  
*Performed by the Area Plan Commission of Tippecanoe County*

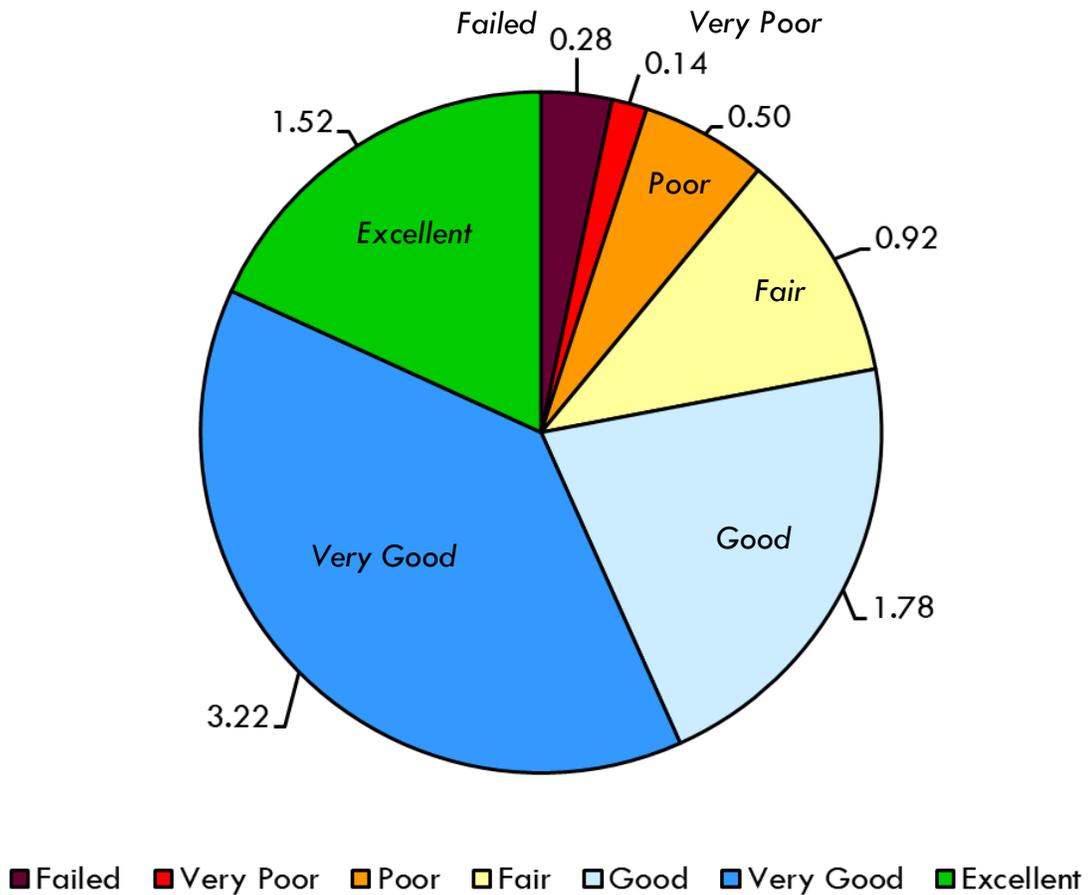
**Figure 1, Miles of Sidewalk by Condition**

Overall the condition of existing sidewalks throughout the town is mostly in good to very good condition. There are five miles of sidewalk that are rated as one of these two conditions. This translates to nearly three-fifths (59.8%) of all the sidewalks within the town. Individually, there are 1.78 miles of sidewalk rated in good condition and 3.22 miles rated in very good condition. **Table 1** lists the number of miles and percentage of sidewalks by condition and **Figure 1** shows the number of miles by condition.

**Table 1** and **Figure 1** shows that there are sidewalks rated in poor and very poor conditions. Over six-tenths of a mile (0.64 miles) were rated as one of these two conditions which is 7.7% of all the sidewalks in town. Individually, there were 0.50 miles in poor condition and 0.14 miles in very poor condition.

Unfortunately, there are sidewalks observed that completely failed. APC staff observed just over a quarter of a mile (0.28 miles) of sidewalks in this condition. This translates to 3.3% of the sidewalks in town.

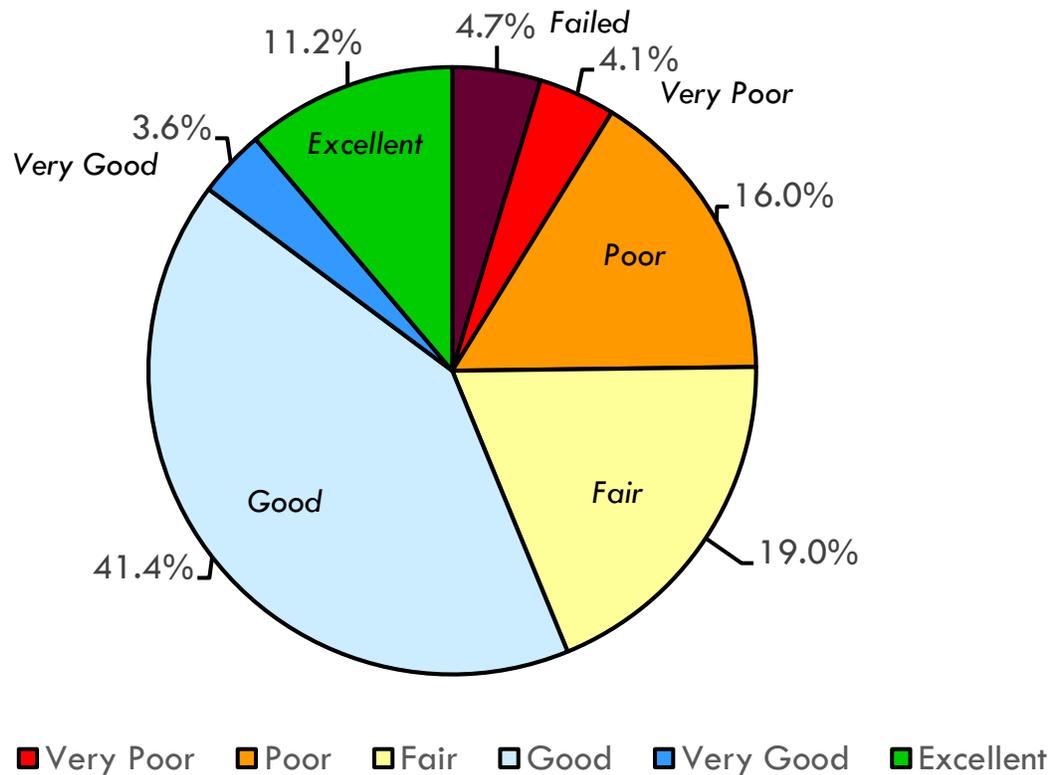
**Figure 2, Sidewalk Conditions in the Harrisonville Area by Percentage**

There are 1.69 miles of sidewalk in this portion of town ranging from excellent condition to failing. **Table 2** shows the mileage and percentage of sidewalk by condition and **Figure 2** shows the condition by percentage. Nearly all of the sidewalks in this portion of town are constructed of concrete. There is one small section, on Main Street west of East Street, that is brick.

Overall, the majority of sidewalks, 60.4%, in this area of town are either in fair or good condition with over 40% being in good condition. These sections can be found toward the western end of Main Street, on Jefferson Street, on High School Avenue between Jefferson Street and Tippecanoe Street, on Tippecanoe Street, and along both sides of Tomahawk Lane. **Figure 3** shows the location of these segments.

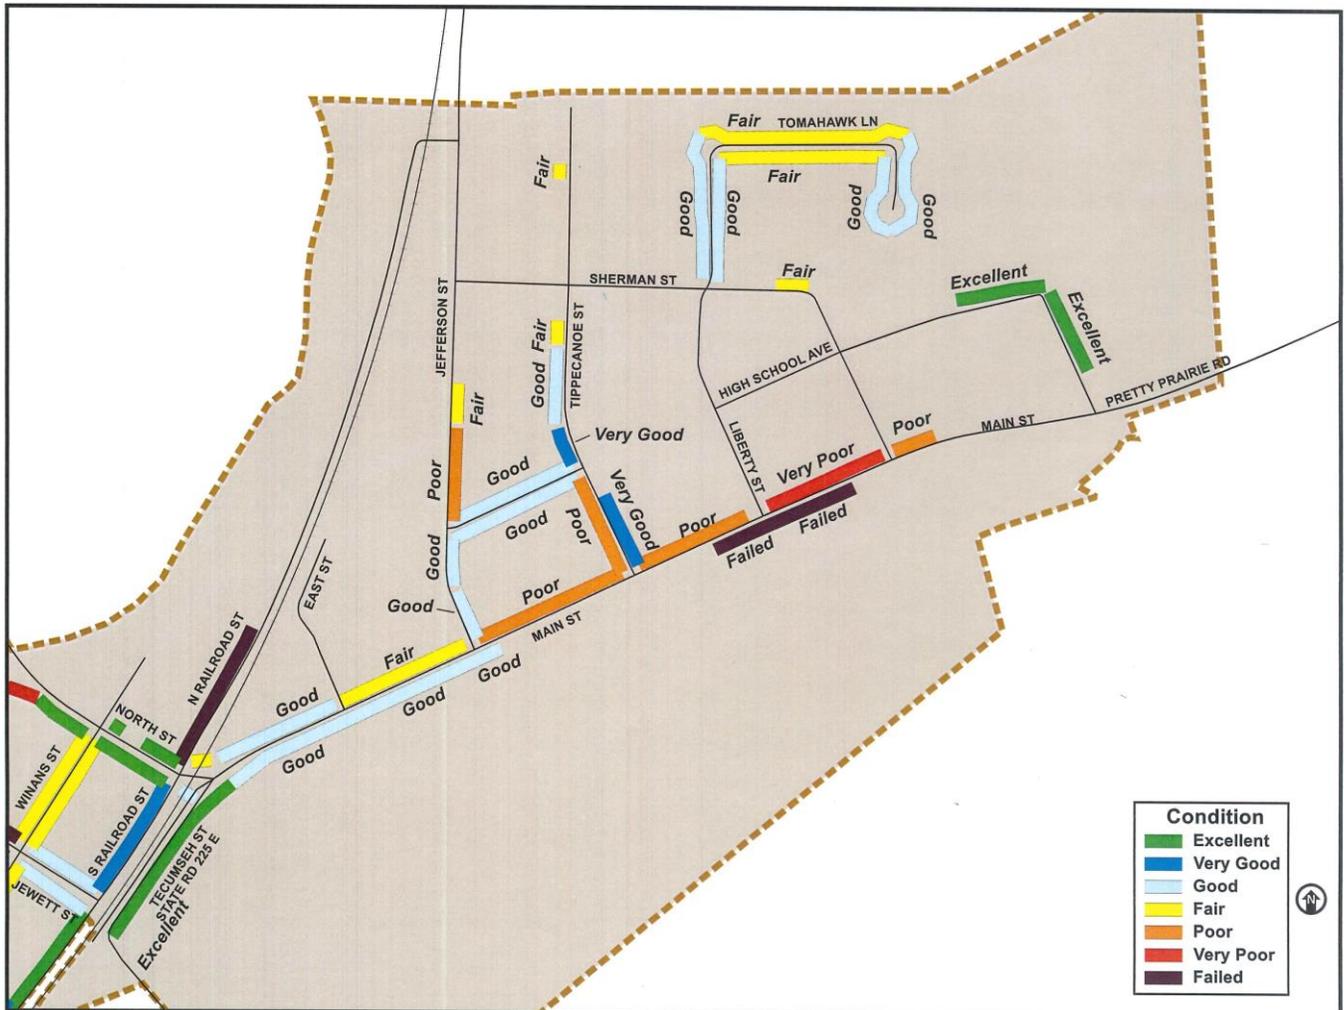
**Figure 3, Sidewalk Conditions in the Harrisonville Area**

Sidewalks rated very good and excellent are located at three locations: along Tecumseh Street, along Tippecanoe Street and at the very eastern end of High School Avenue. Nearly all of the sidewalks in these three locations appear to be new or fairly new.

Sidewalks rated from poor to failed are found along Main Street and two sections on Jefferson Street and Tippecanoe Street. Nearly a quarter of sidewalks in this

portion of town are found to be in one of these three conditions. The two sections observed that failed are on the south side of Main Street both east and west of Liberty Street. These two sections account for nearly five percent of the sidewalks in this area and nearly a tenth of a mile. The one section of sidewalk rated in very poor condition is in the same area but on the north side of Main Street. Sidewalks both east and west of this location are rated in poor condition.

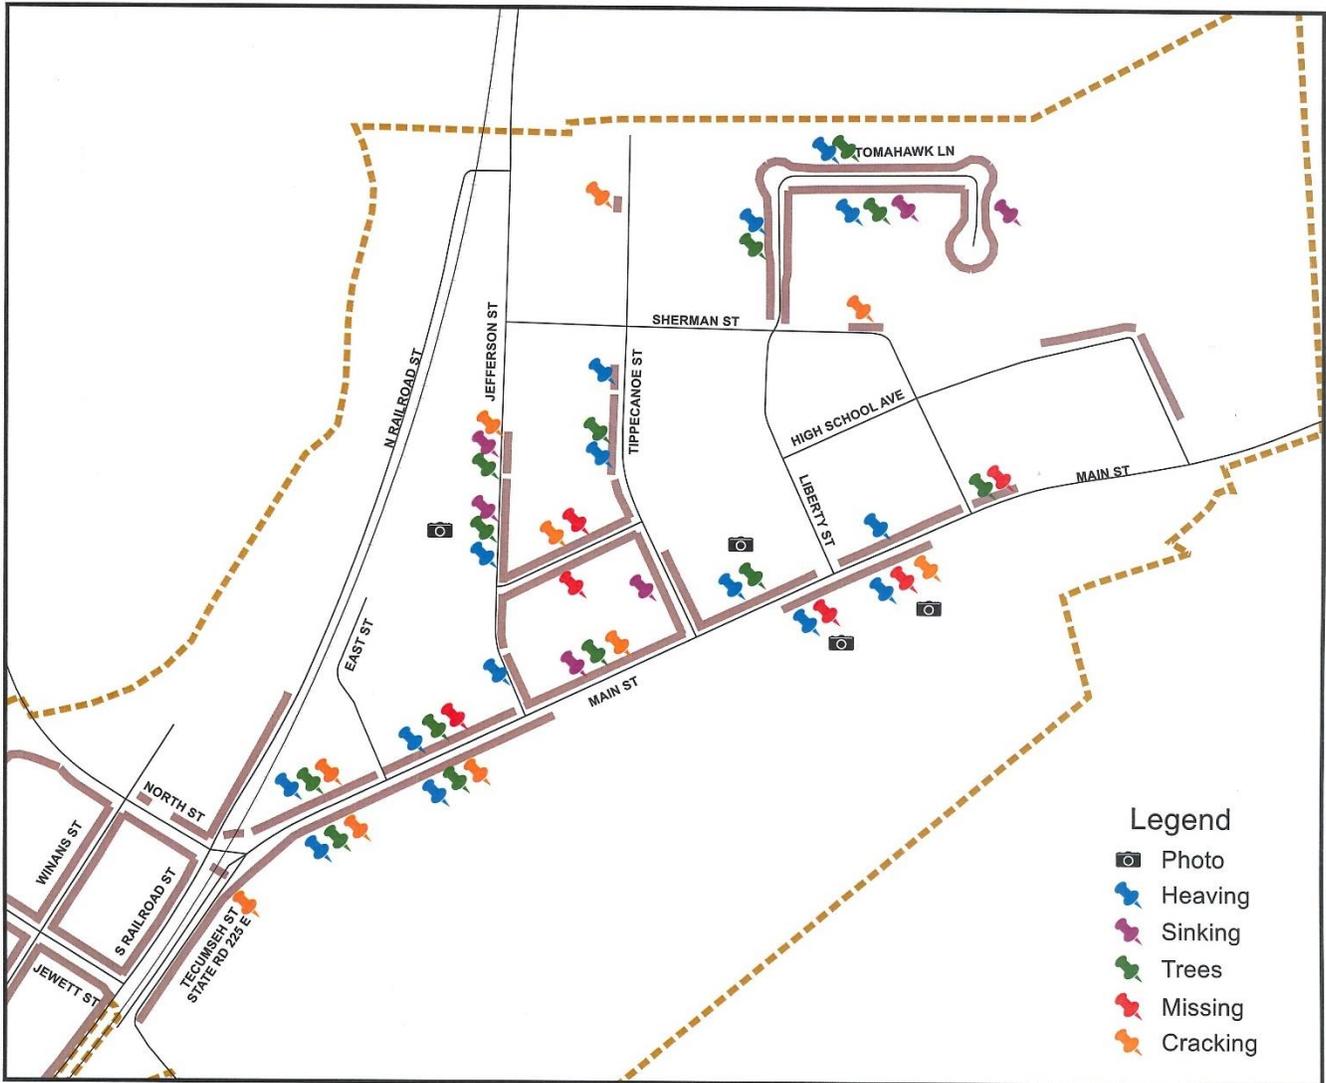
**Figure 4, Location of Observed Issues in the Harrisonville Area**

Even though many of the sidewalks in this portion of the town were observed to be in fair to good condition, there are locations where condition issues were observed. **Figure 4** shows those sections of sidewalks where APC staff observed heaving, sinking, missing, cracking and issues due to trees. Nearly every sidewalk in this area of town has at least one condition issue.

The most observed issue is heaving in which the sidewalk was pushed upward. Fifteen of the 33 sections have some sort of heaving. The culprit that is mostly to blame are trees. **Photo A** shows an example.

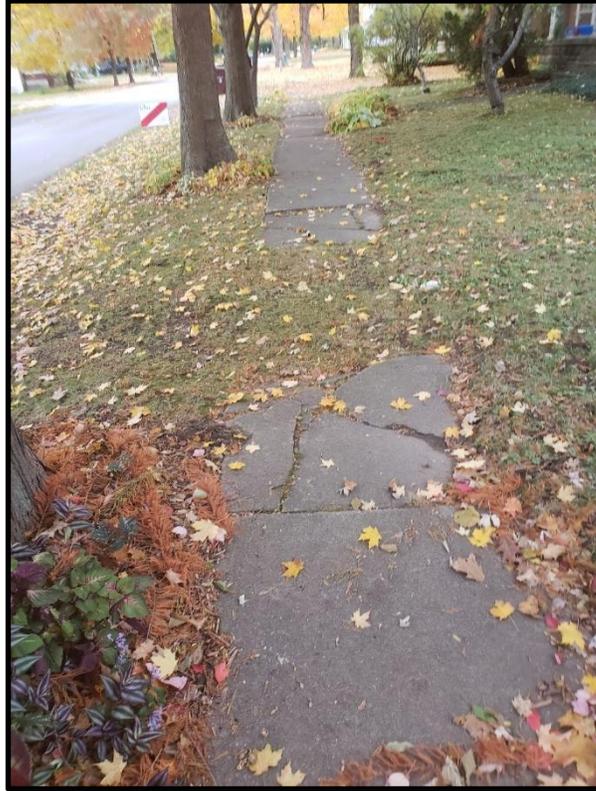
**Photo C, Main Street East of Liberty Street**

Heaving was not the only reason why the two sections of sidewalk on Main Street received a failed rating. Sections missing, and cracking are the other culprits. **Photo C** shows a good example of a missing section.

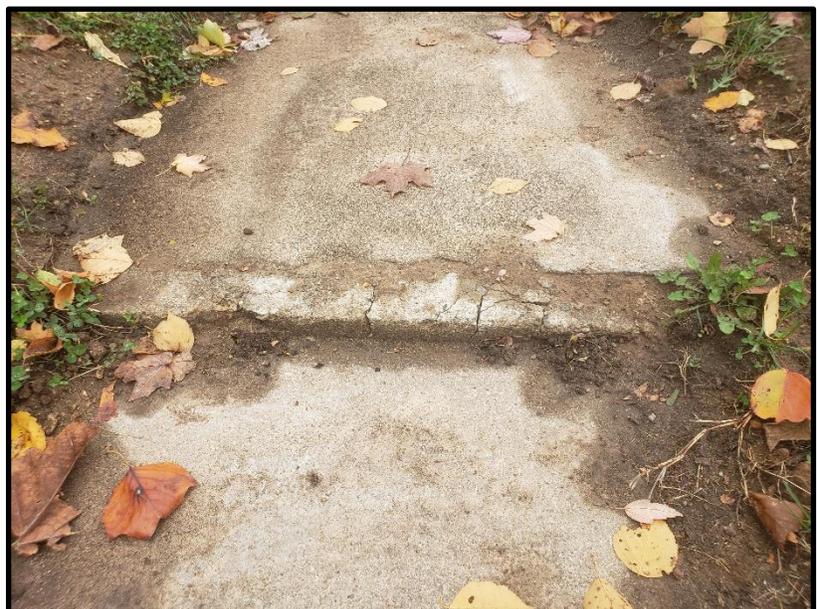
**Photo D, Main Street West of Liberty Street**

APC staff observed several other issues in this area of town. There are twelve sections where cracking is observed. There are six sections where one or more slabs sank. **Photo D** shows one location on Main Street west of Liberty Street where a slab sank.

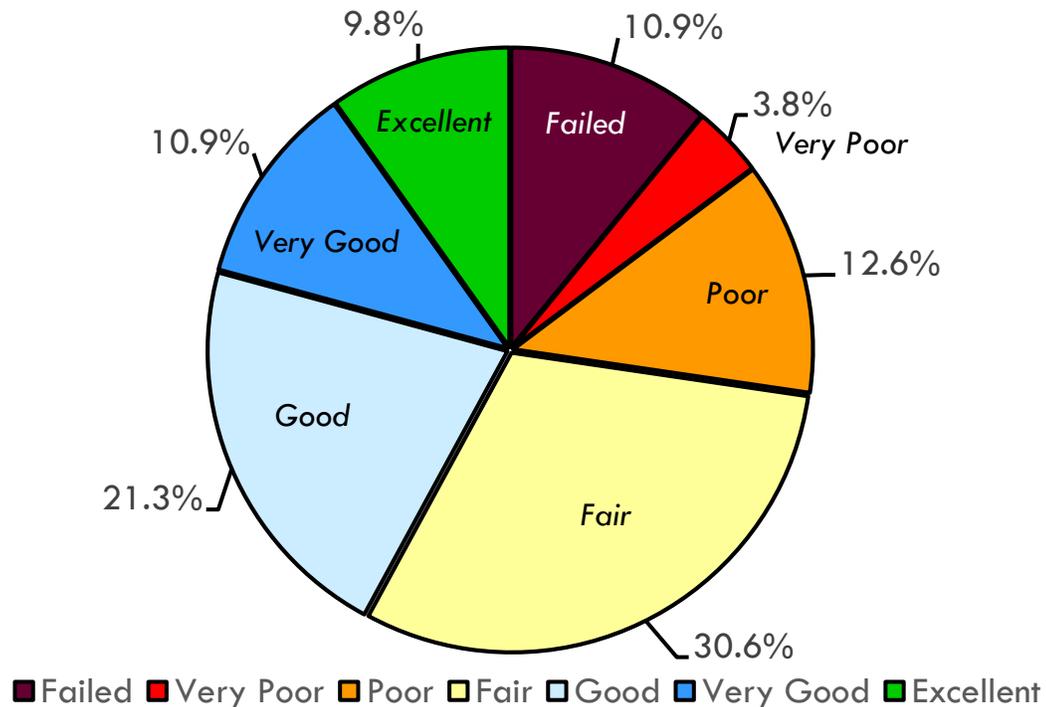
**Figure 5, Sidewalk Condition in the Old Battleground Area by Percentage**

In this area of town, there are 1.83 miles of sidewalk and they range from being in excellent condition to failing. **Table 3** shows the mileage and percentage of sidewalk by condition and **Figure 5** visually shows the condition by percentage. Nearly all the sidewalks in this portion of town are also constructed of concrete. There are three sections: one on North Street and the two crossing the CSX Railroad tracks, that are comprised of asphalt.

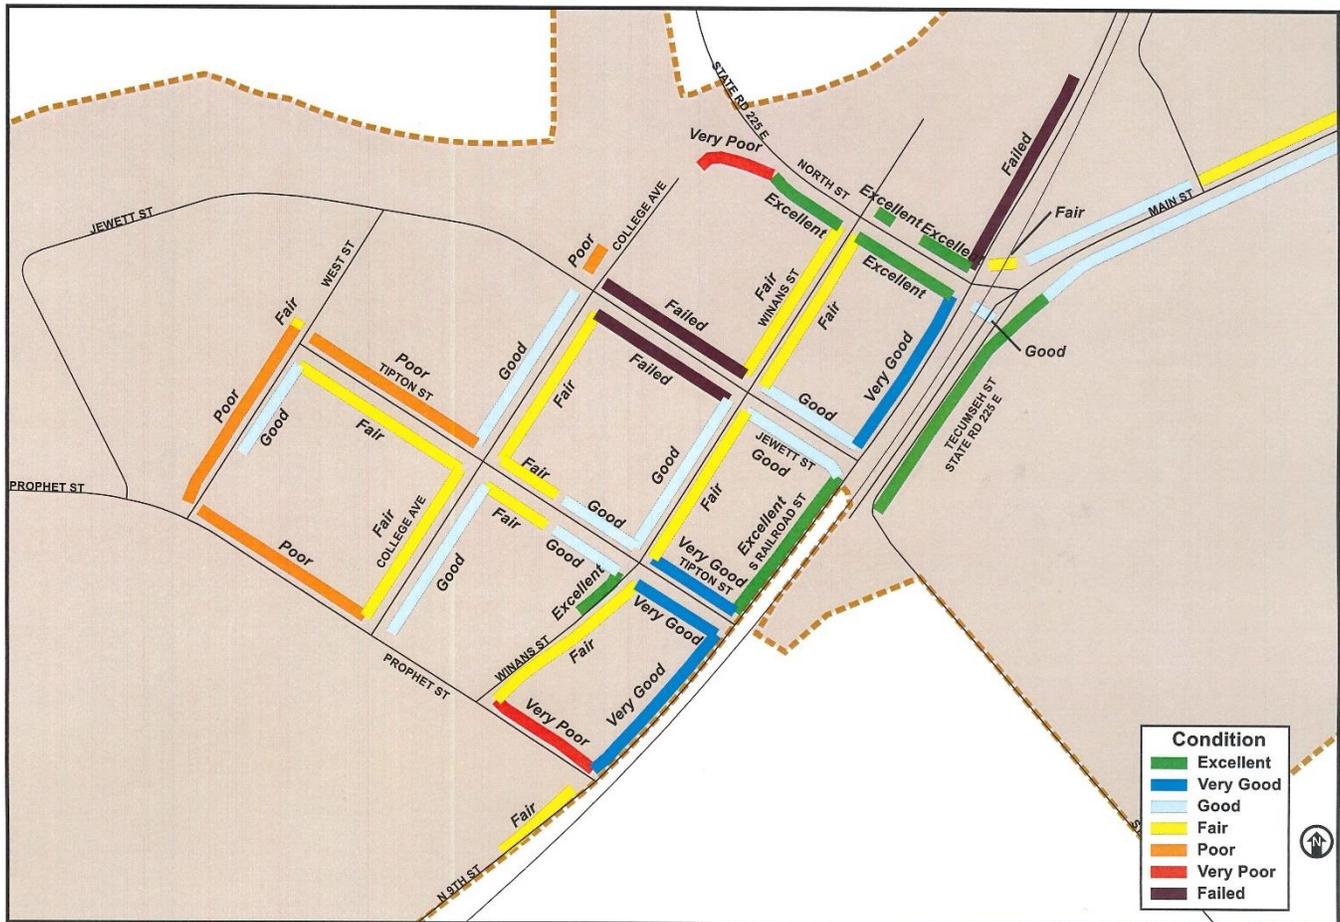
**Figure 6, Sidewalk Conditions in the Old Battle Ground Area**

A fifth, 20.8%, of the sidewalks in this portion of town were found to be in very good to excellent condition. They are located along the majority of North and Railroad Streets and several segments of Tipton and Winans Streets. The reason for the ratings along Railroad and North Streets is due to two federal aid transportation projects. Money from the Federal gas tax paid for 80% of the cost to build the sidewalks. **Figure 6** shows the condition of sidewalks in this area of town.

Looking at the other end of the condition scale, there are three sections observed that failed, 0.2 miles, and two in very poor condition, 0.07 miles. The percentage of sidewalk in these two conditions is less than those with an excellent and very good rating. Railroad Street north of North Street and the sidewalks along both sides of Jewett Street between College Avenue and Winans Street are the three segments observed to have failed. The section of Prophet Street west of Railroad Street and the asphalt path from the end of College Street to North Street are both rated in very poor condition.

**Figure 6** shows that three of the four sections rated poor are located in the western side of this area of town. They are along Prophet Street, West Street and Tipton Street. The other section rated poor is on College Avenue near the Town Hall.

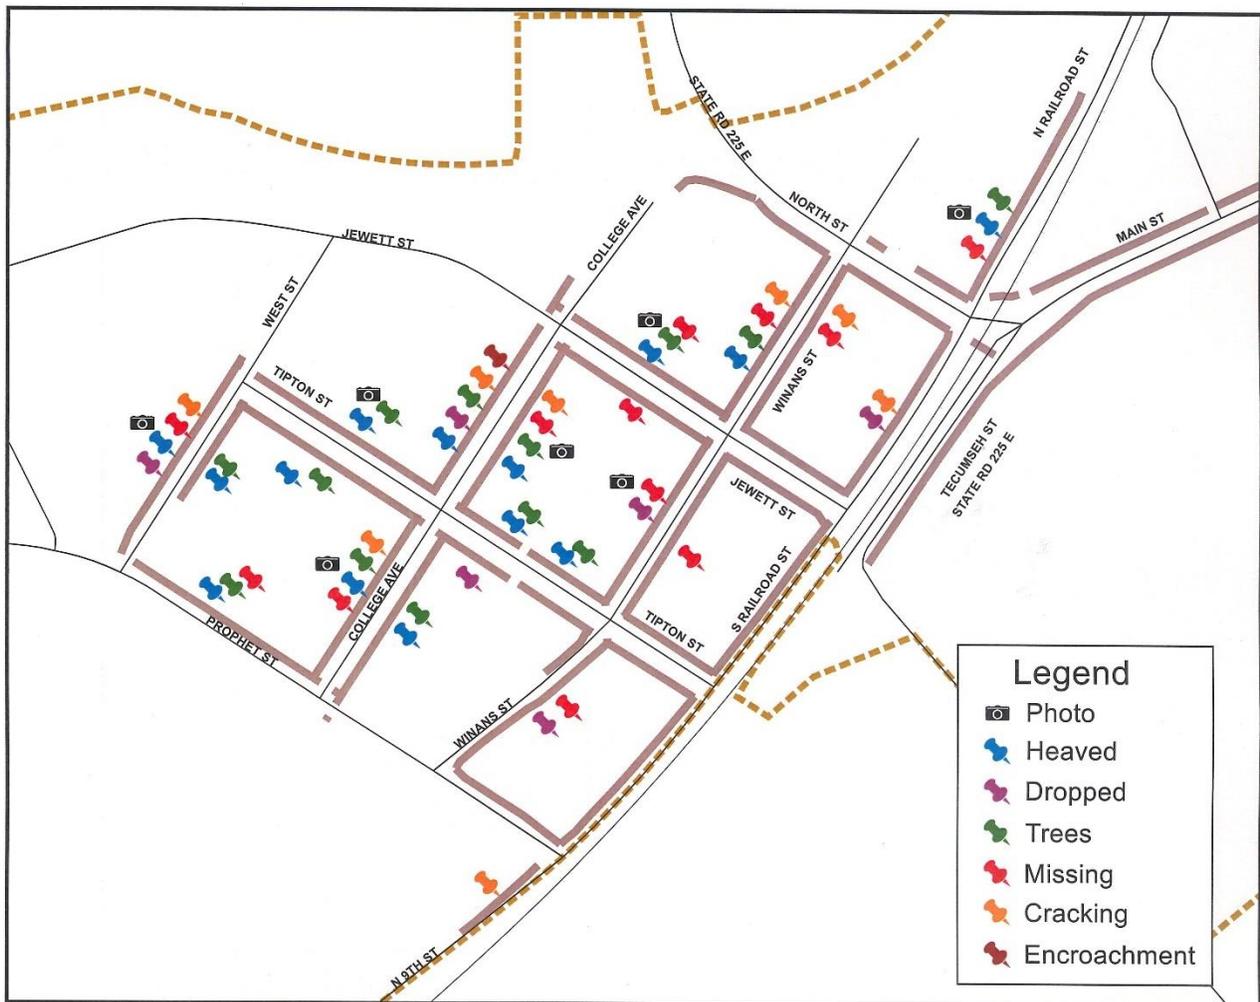
**Figure 7, Location of Observed Issues in the Old Battle Ground Area**

**Figure 7** shows where the heaving, sinking, missing, cracking and issues related to trees are located. Heaving is a significant problem. APC staff observed fourteen sections with varying degrees of heaving ranging from a minimal to a substantial amount. **Photos E, F, G, H** show various heaved sidewalks.

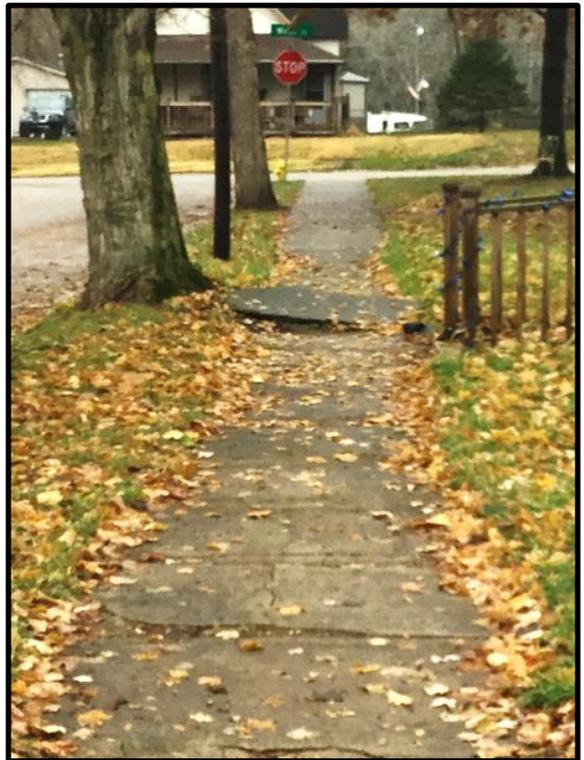
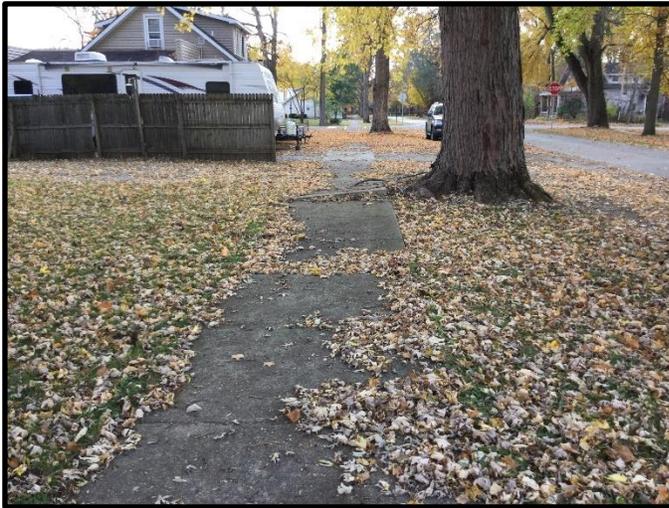
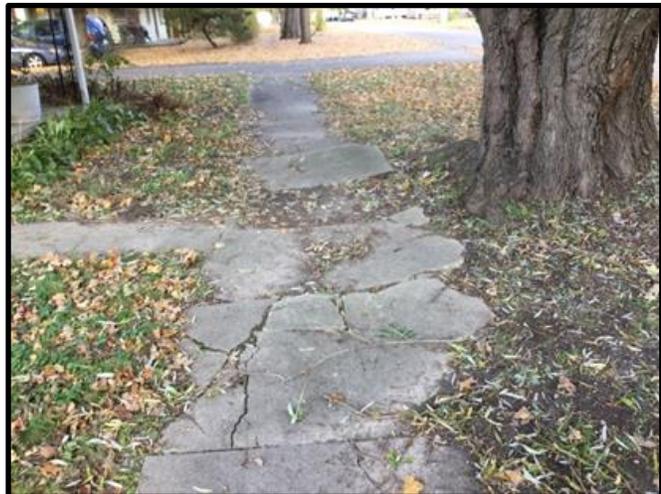
Many of the heaving issues in this area of town are caused by trees. **Photos F, G,** and **H** show this.

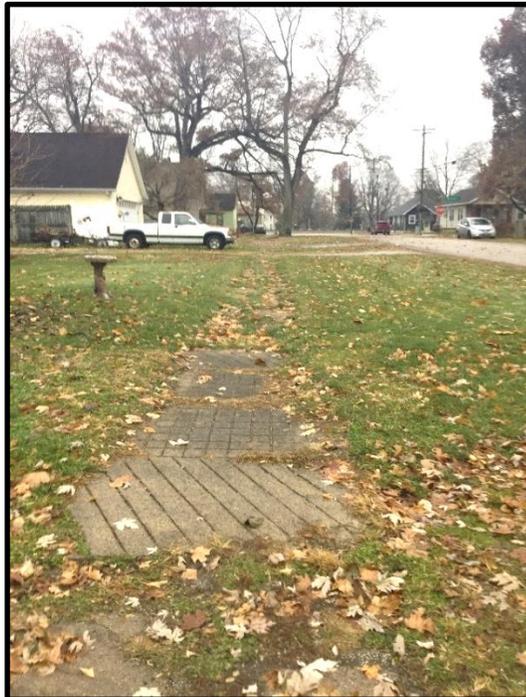
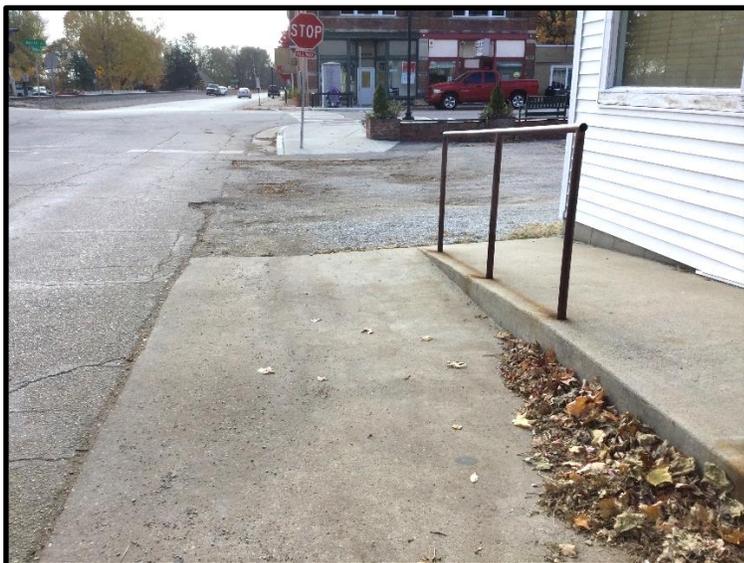
There are a substantial number of sidewalks in this portion of town in which sections are missing. They range from small pieces to complete sections. All three failed sidewalks have missing sections, especially on Jewett Street between Winans Street and College Avenue. **Photo I** shows one of the locations on College Avenue. **Photo J** shows a substantially missing section on Railroad Street just north of North Street. It appears that the missing sidewalk could be a driveway or part of a parking lot.

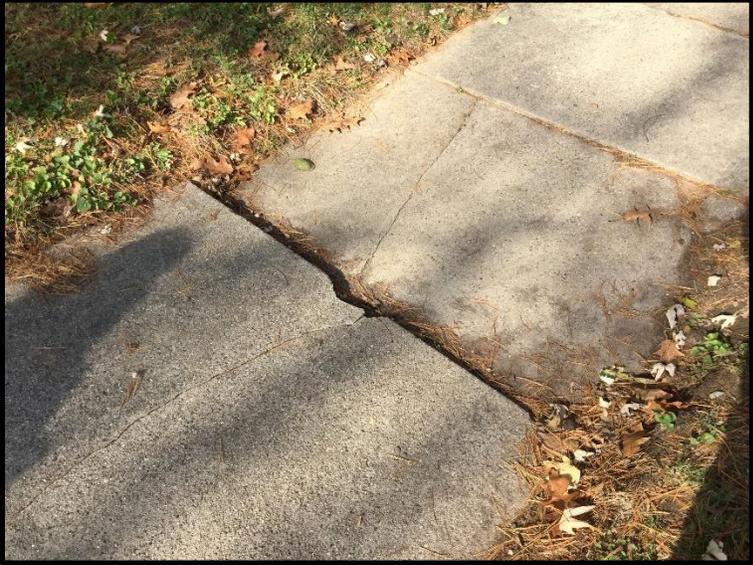
**Photo K, Winans Street Between Jewett Street and Tipton Street**

Sections of sidewalk that sank are also present and located at various locations. **Photo K** is an example of a slab that sank.

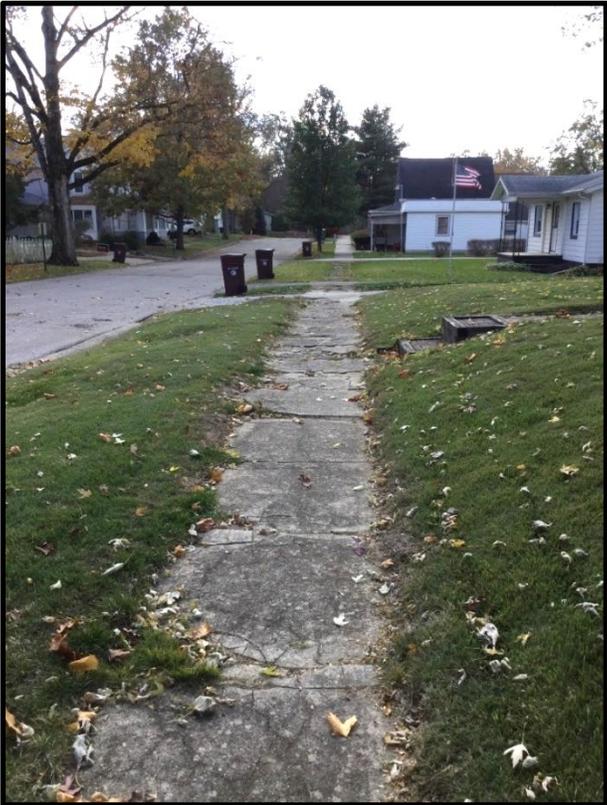
**Photo L, West Street Between Tipton Street and Prophet Street**

APC staff observed various sections that have a combination of issues including heaving, sinking, missing and/or cracking. **Photo L** shows one section that has a combination of these issues. This section also had some segments replaced.

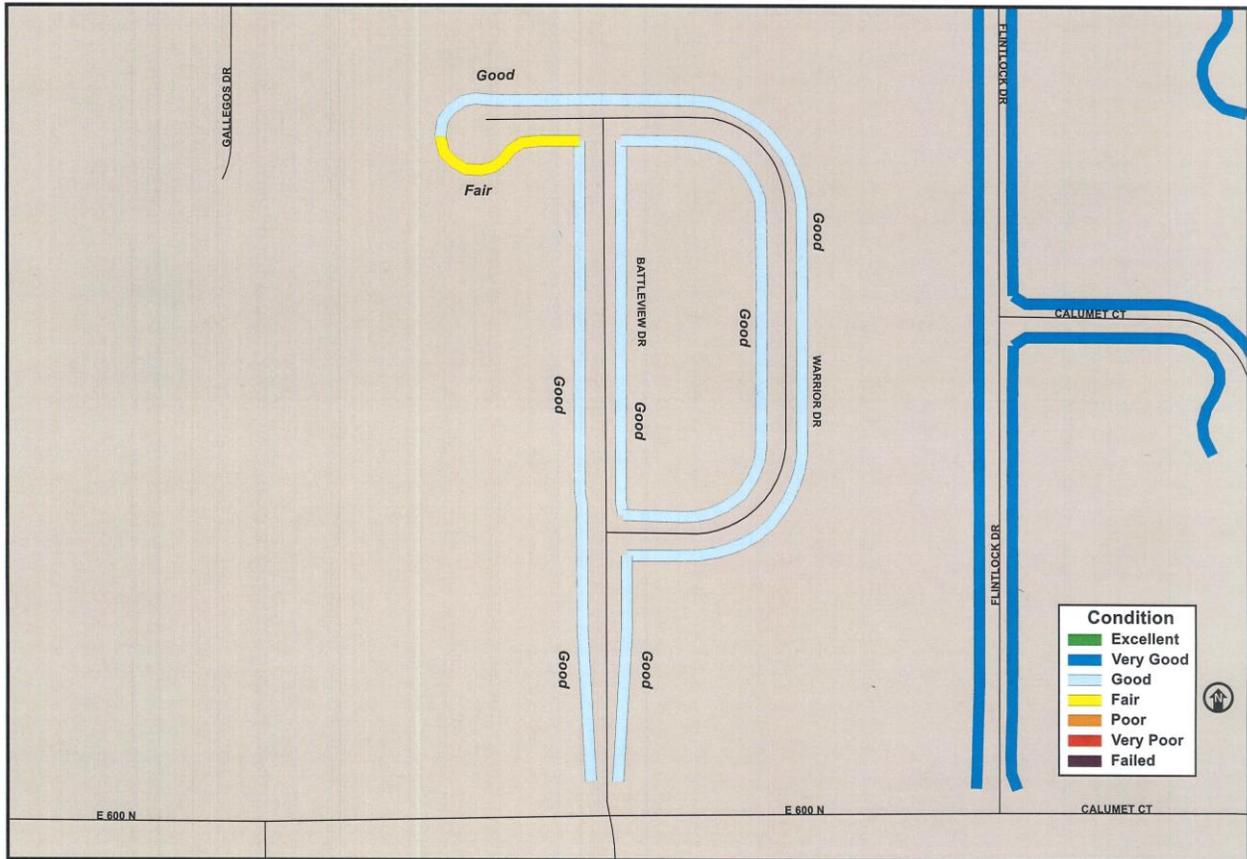
**Figure 8, Sidewalk Conditions in the Harrison Meadows Subdivision**

There are just under three quarters of a mile of sidewalks within the subdivision and nearly all, 94.5%, are in good condition. The one section that is not rated good is rated in fair condition. This is due to one section that is comprised of brick rather than concrete. Grass is substantially growing between each brick and the surface is very irregular and not level. **Table 4** shows the conditions by miles and percentage and **Figure 8** shows the conditions by segment.

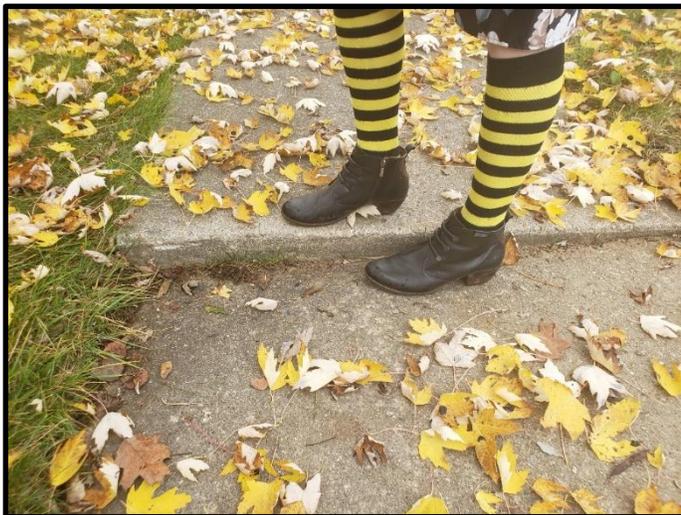
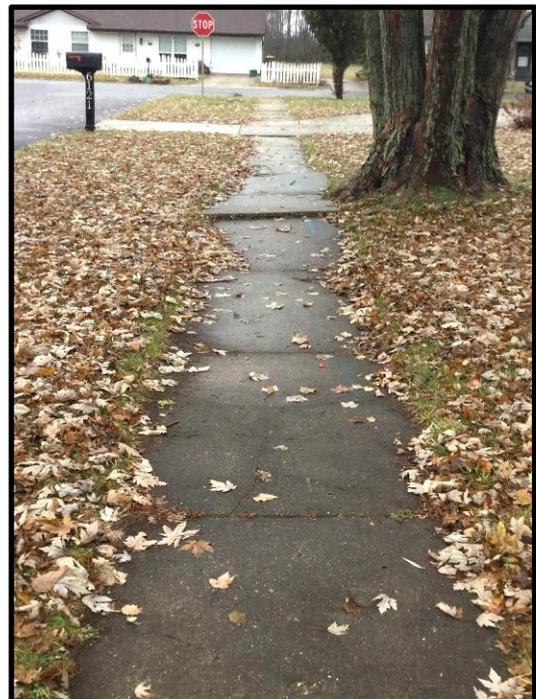
Similar to the previous observations, the major issue here is heaving. Five of the eight sections have some varying degree of heaving. And similar to the previous areas, the culprit that caused this condition is trees. **Photos M** and **N** show heaving at two locations. **Figure 9** shows the observed issues by condition.

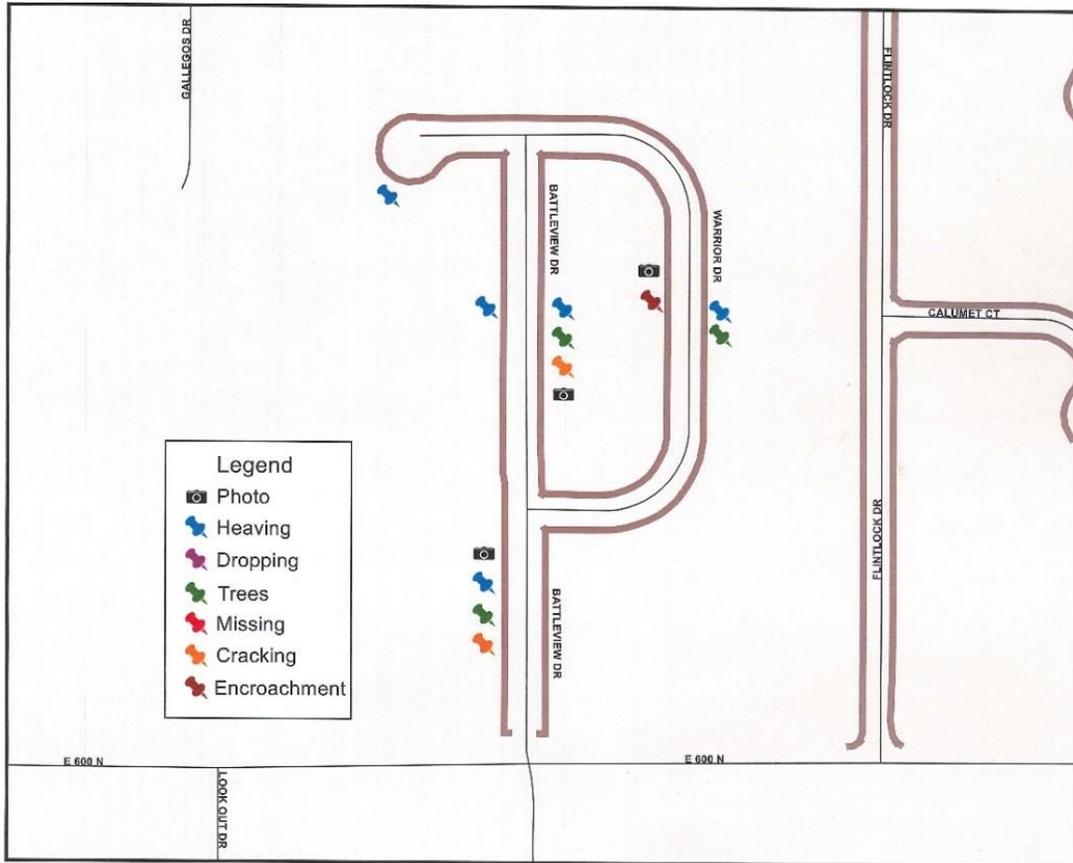
**Figure 9, Location of Observed Issues in the Harrison Meadows Subdivision**

Other issues were observed. Cracking and grass growing between the sidewalk joints were observed at various locations within the subdivision. Cracking is not as substantial as in the previous two areas.

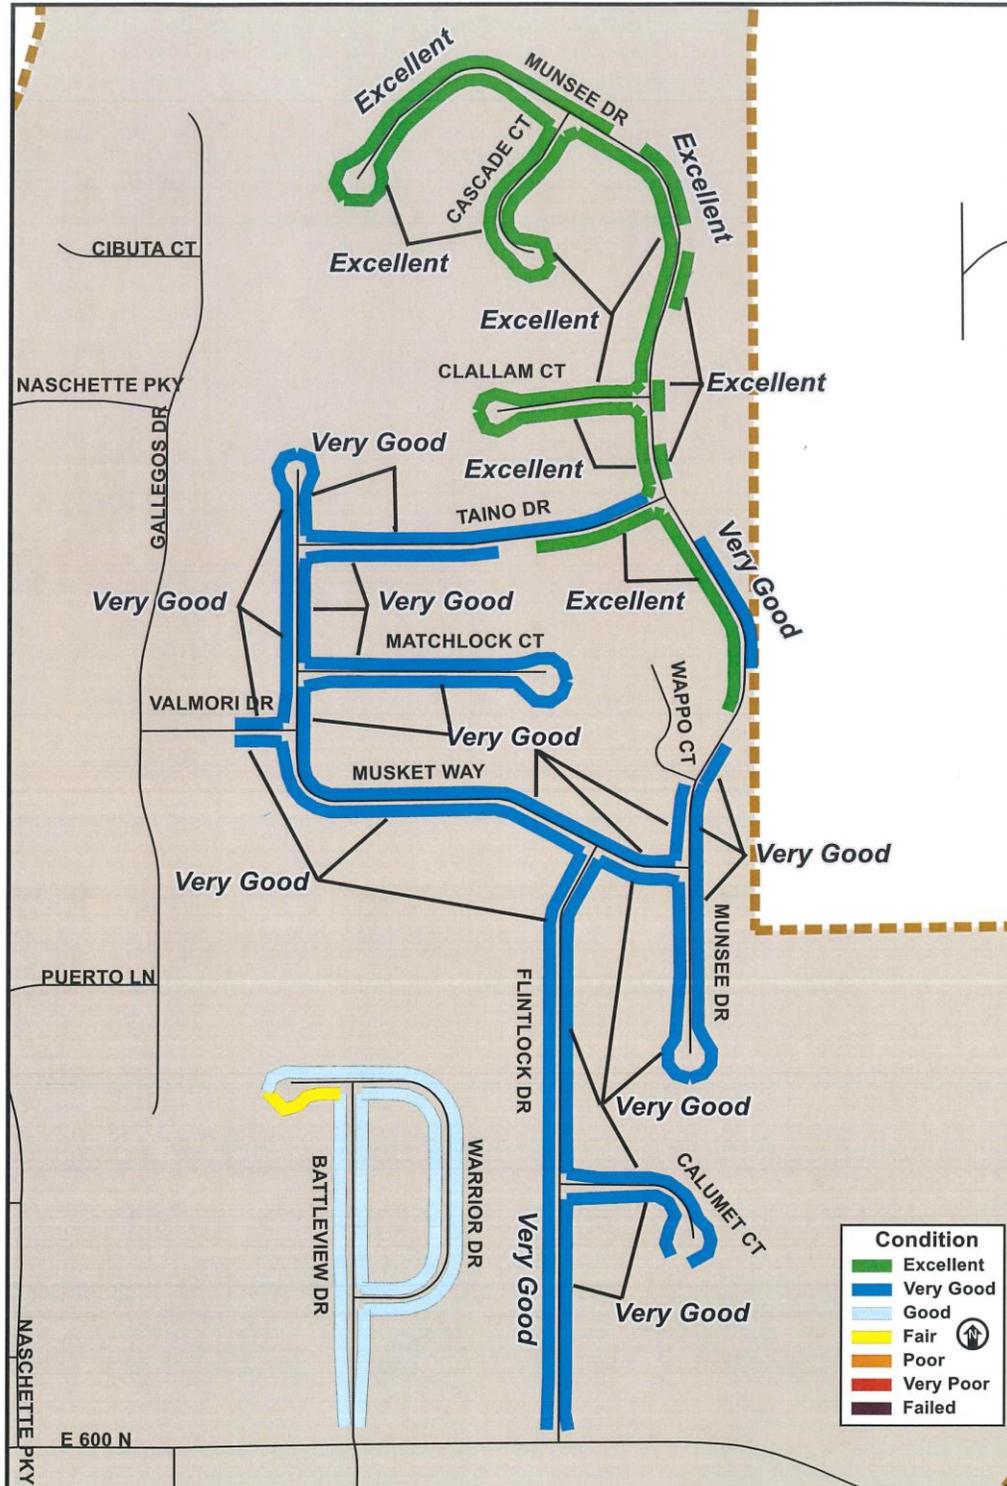
**Figure 10, Sidewalk Conditions in the Shawnee Ridge Subdivision**

Over 40%, or 3.51 miles, of the town's sidewalks are located in this subdivision and since this subdivision is relatively new, all of them are rated as either very good or in excellent condition. The southern and western parts of the subdivision, the oldest sections, are rated very good, 2.36 miles, while the northern section are rated as excellent, 1.15 miles. **Table 5** shows this breakdown and **Figure 10** shows the condition of sidewalks in this portion of the town.

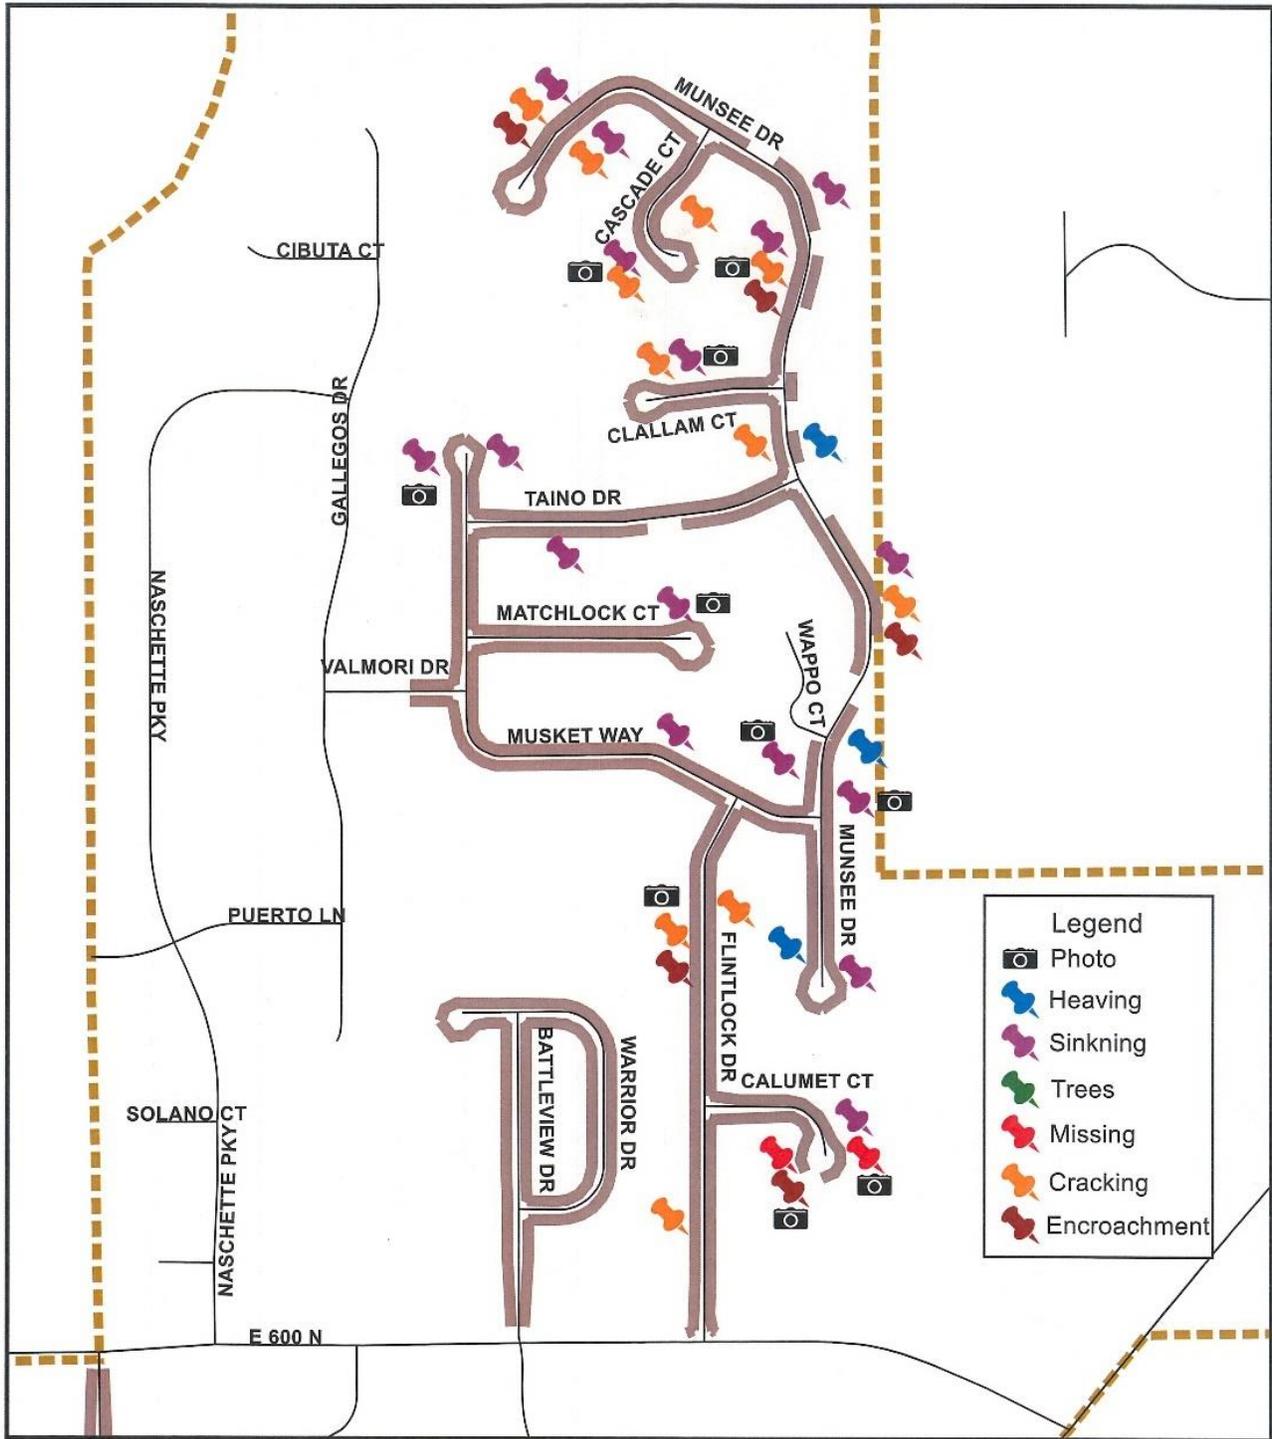
Figure 11, Location of Observed Issues in the Shawnee Ridge Subdivision

While sidewalks in Shawnee Ridge range from nearly 20 years old to brand new, APC staff observed various issues throughout the subdivision. The issues include sinking, cracking, missing, heaving, cracking and encroachment. **Figure 11** shows the locations of the observed issues.

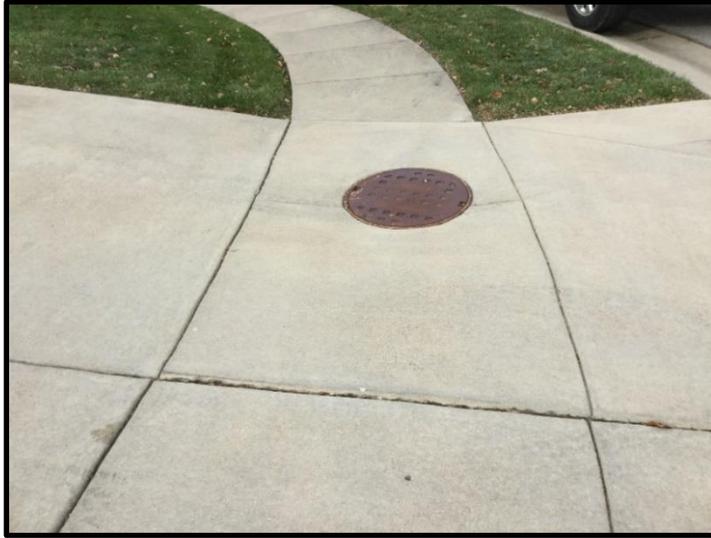
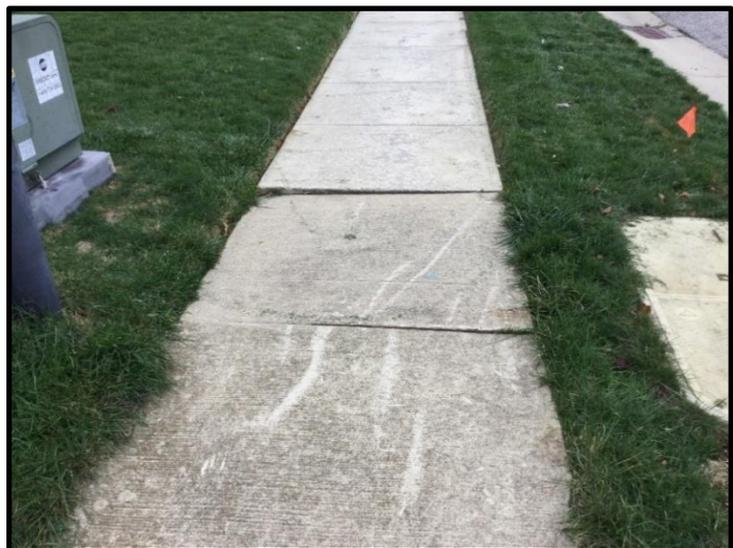
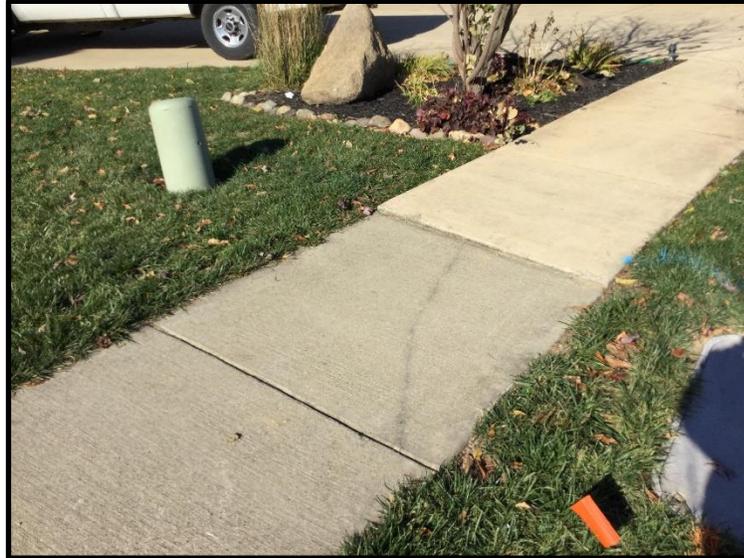
The most common issue is sinking, and it was found throughout the subdivision. It is even present in the northern sections where the sidewalks are in excellent condition. There is one culprit that mainly caused this issue and it is utilities. They are either installed within the path of the sidewalk or on either side. **Photos P, Q, R, S, and T** show examples of the issue.

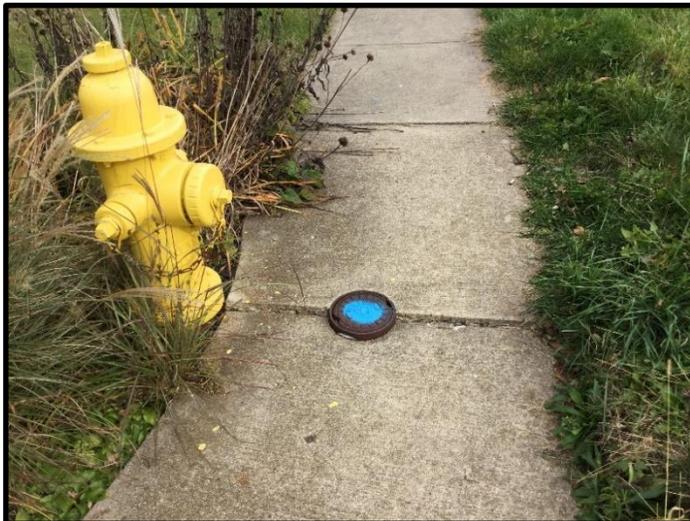
**Photo Q, Matchlock Court**

APC staff also observed other issues caused by utilities. **Photos Q** and **U** show two locations where they are protruding above the sidewalk surface.

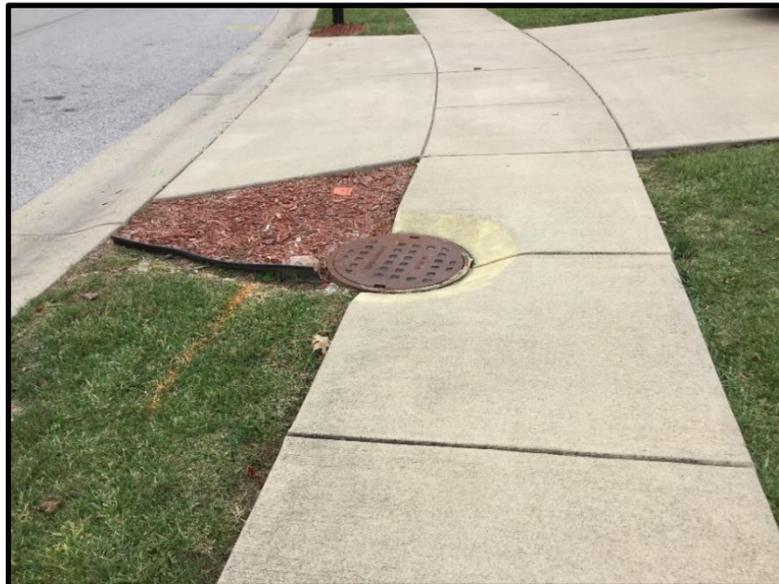
**Photo T, Munsee Drive  
South of Wappo Court**

**Photo T** shows a dangerous spot in which the manhole is significantly lower than the sidewalk. The sidewalk is even painted, although very faded, to warn pedestrians of the danger.
