# Town of Battle Ground Sidewalk Condition Survey

# Town of Battle Ground

## Tippecanoe County, Indiana

*Sidewalk Condition Survey*  
*Performed by the Area Plan Commission of Tippecanoe County*

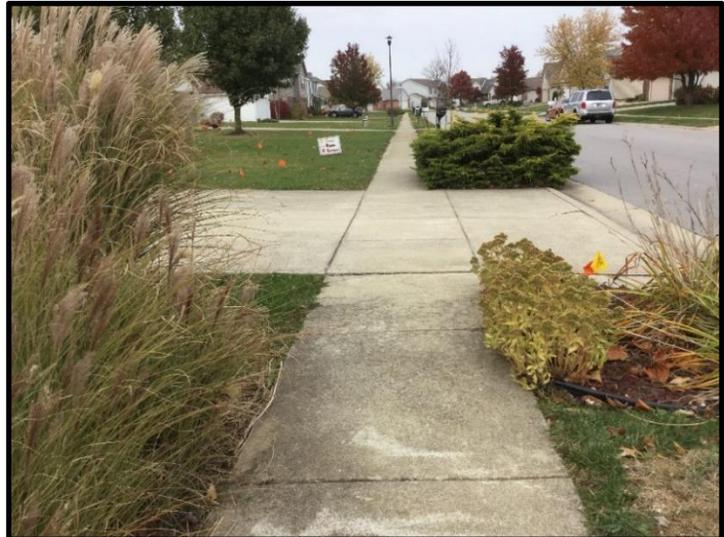
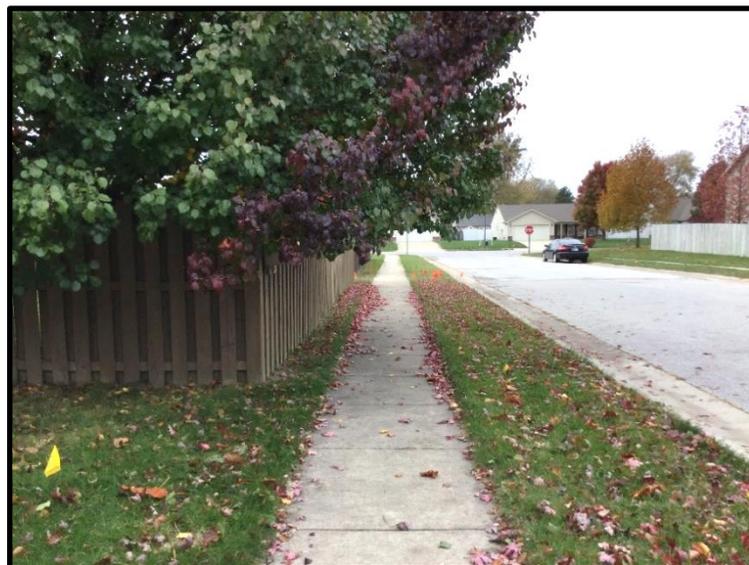
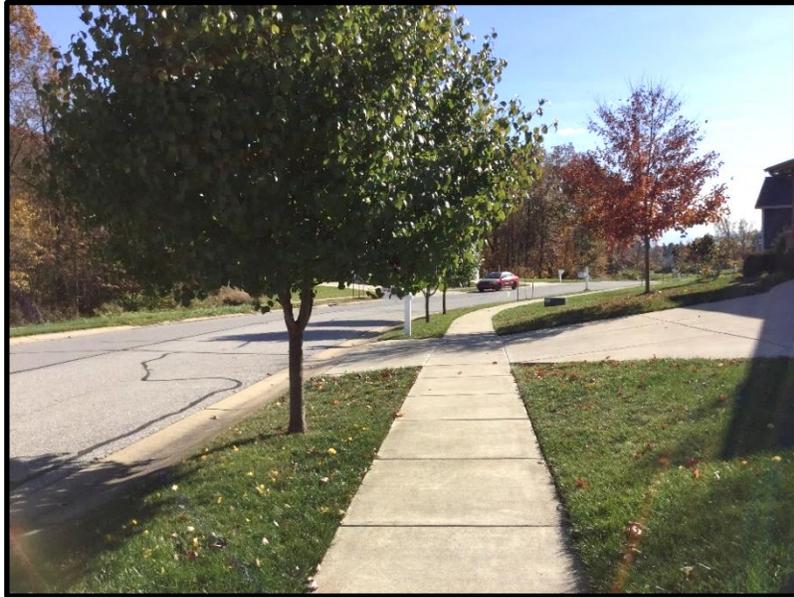
No issues were observed from trees heaving the sidewalks, but there are several sections where bushes, shrubs and trees partially blocked the path. **Photos V, W** and **X** show several of those locations.

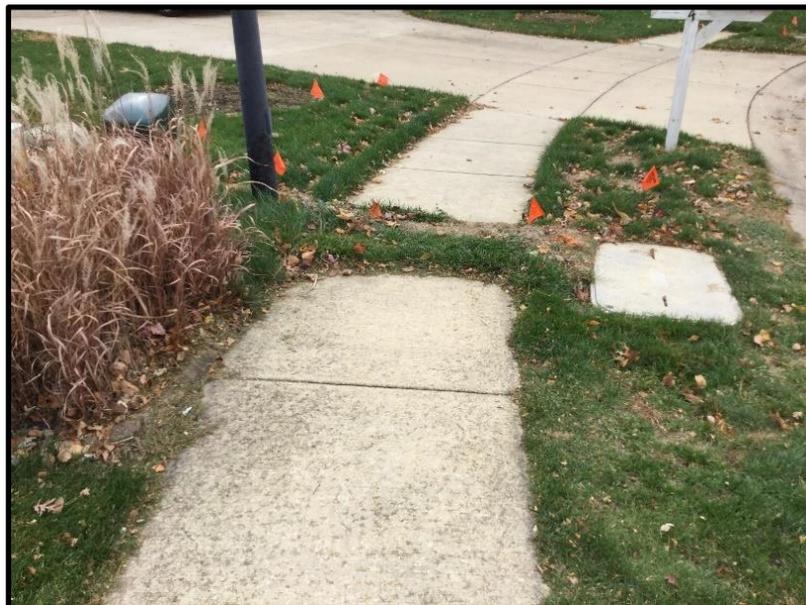
**Photo Y, Calumet Court**

Regarding missing sections, there is one spot where it appears utilities were installed, and the section of sidewalk was removed during installation. Unfortunately, the sidewalk was not reinstalled after the work was completed. **Photo Y** shows the spot.

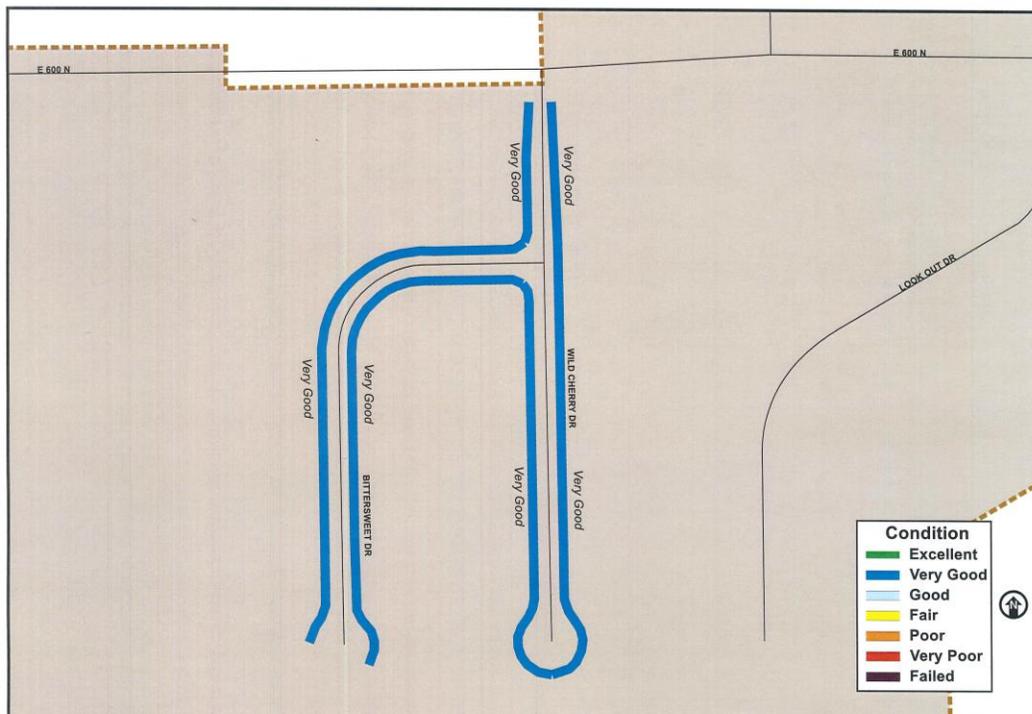
**Figure 12, Sidewalk Conditions in the Quail Ridge Subdivision**

There is six-tenth of a mile of sidewalks within the subdivision, are all rated in very good condition. **Table 6** shows the condition by miles and percentage and **Figure 12** shows the condition by segment.

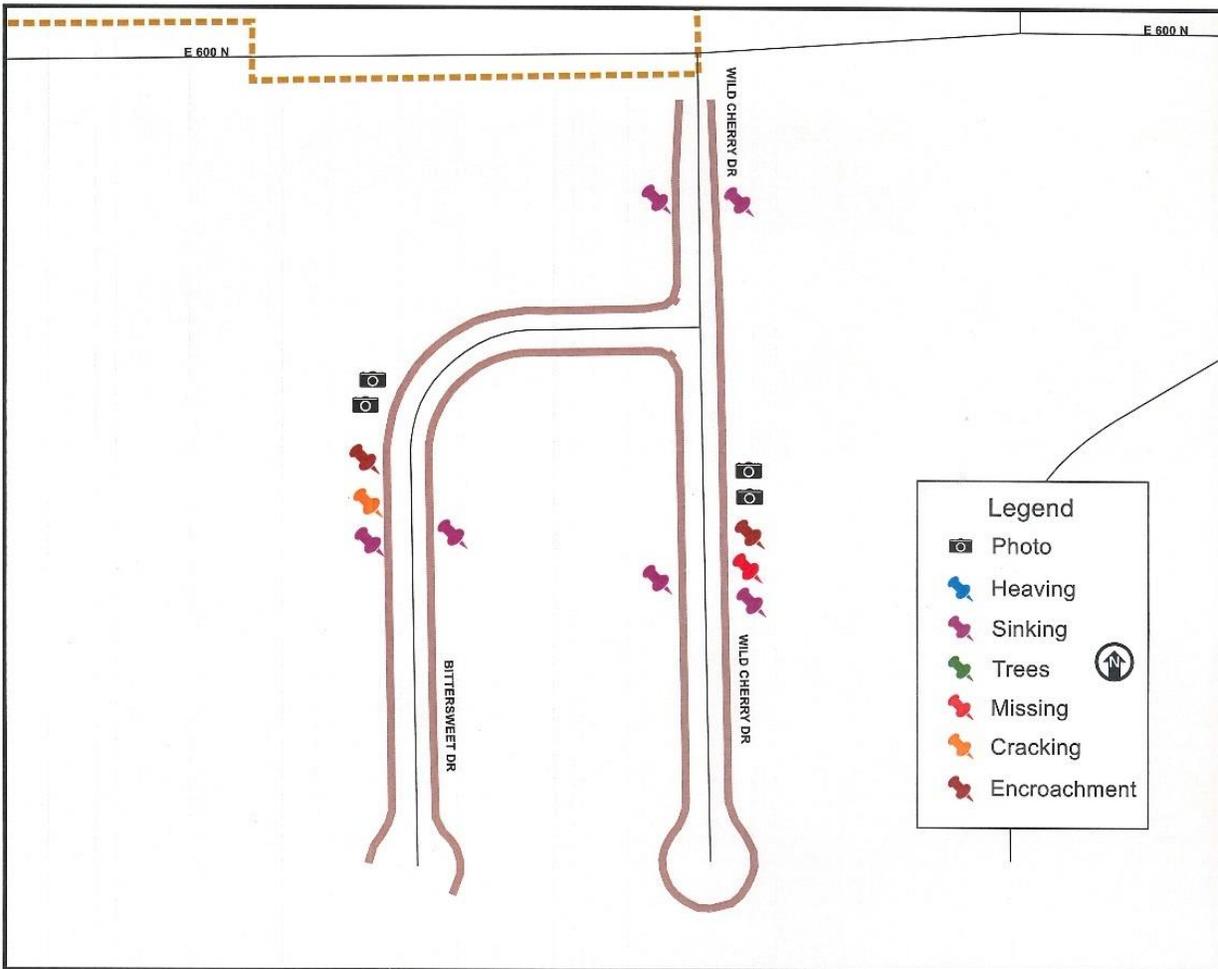
**Figure 13, Location of Observed Issues in the Quail Ridge Subdivision**

Overall there were no major outstanding issues observed within the subdivision. All the issues are minor especially when compared to the other parts of the town. **Figure 13** shows where the minor issues were observed. The issue most observed is sinking and nearly all the sinking was observed either between driveways and sidewalks or where utilities are located.

On Wild Cherry Drive, APC staff observed one spot where there appeared to be a six-inch hole in the sidewalk and is marked on **Figure 13** with the missing symbol.

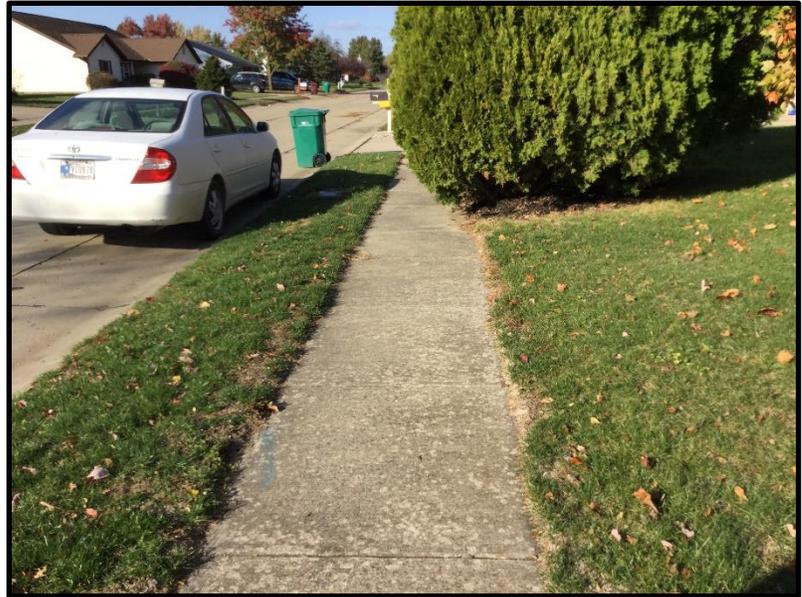
**Photo Z, Bittersweet Drive  
West of Wild Cherry Drive**

At two locations a pine tree and bush are growing over the sidewalk. The pine tree is located on Bittersweet Drive just west of Wild Cherry Drive and the bush is located on Wild Cherry Drive. **Photo Z** shows the pine tree.

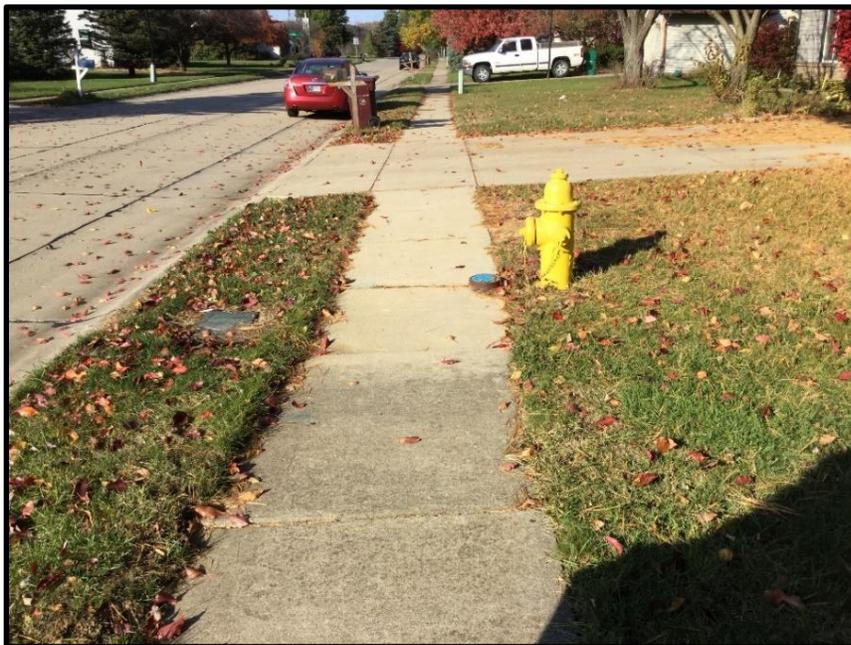
**Photo AA, Wild Cherry Drive South of Bittersweet Drive**

There were a few issues observed related to utilities. **Photo AA** shows a water utility pipe protruding above the sidewalk on Wild Cherry Drive. **Photo AB** shows a fire hydrant on the edge of the sidewalk. Interestingly, the builder who installed the sidewalk added a bump on the opposite side of the hydrant so the sidewalk would still be the full standard width.

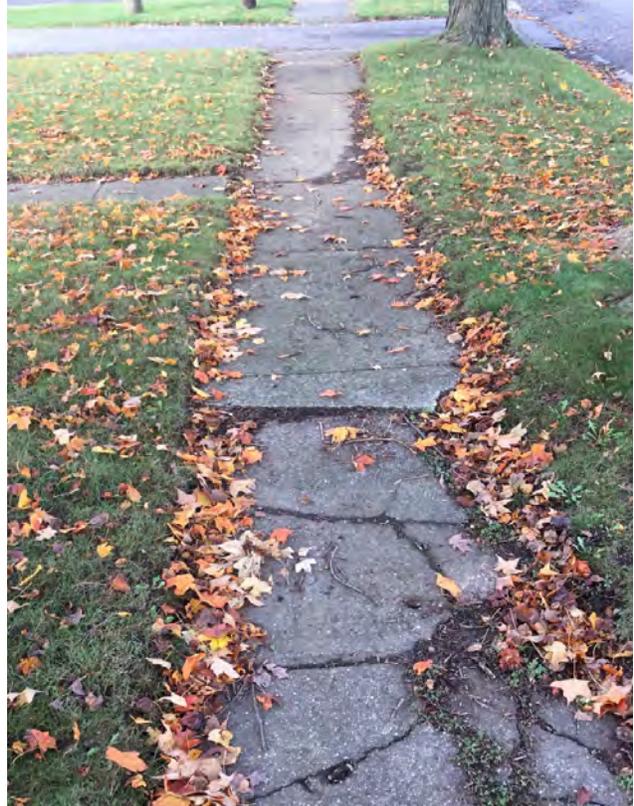
Figure I. Concrete Modified PASER Field Guide

Example of a surface defect problem spot

<b>1</b> Failed	<b>Failed</b> Frequent raised/depressed areas (over 2") Over 50% severely cracked squares of concrete or with severe spalling of concrete surface. Over 50% covered by debris/vegetation. Sidewalk is impassible.	Needs total Replacement.

The modified concrete PASER system is described in Figure 1 and illustrated on the following pages.

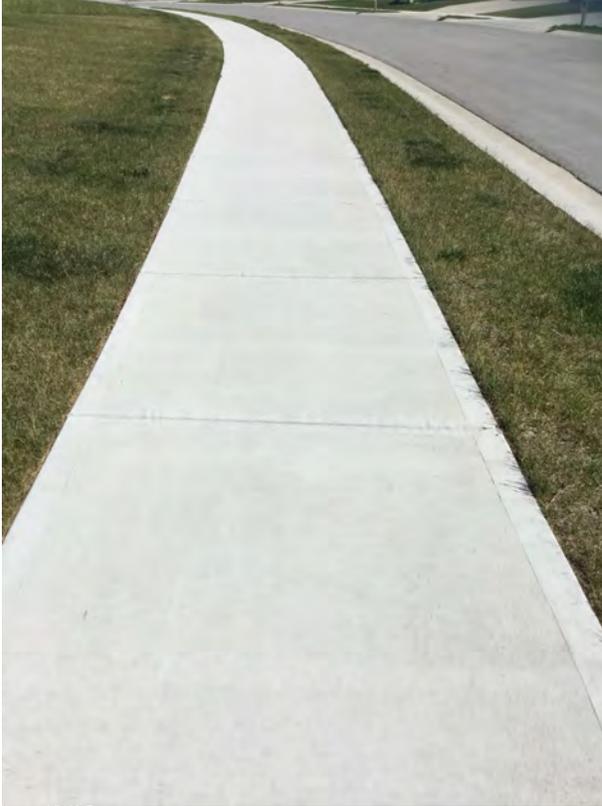
### CONCRETE RATING 10

EXCELLENT – New pavement. No maintenance required.

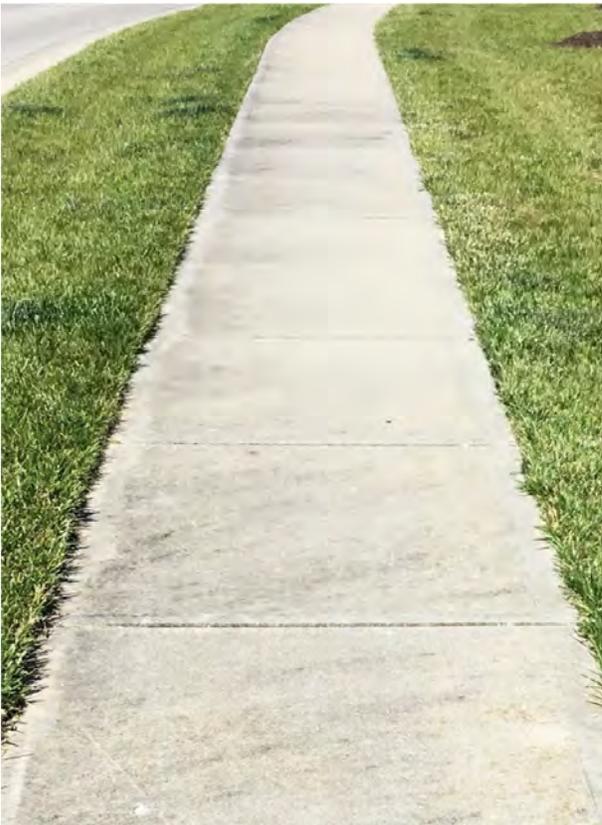
### CONCRETE RATING 9

EXCELLENT – Like-new sidewalk. Some traffic and surface wear. No maintenance required.

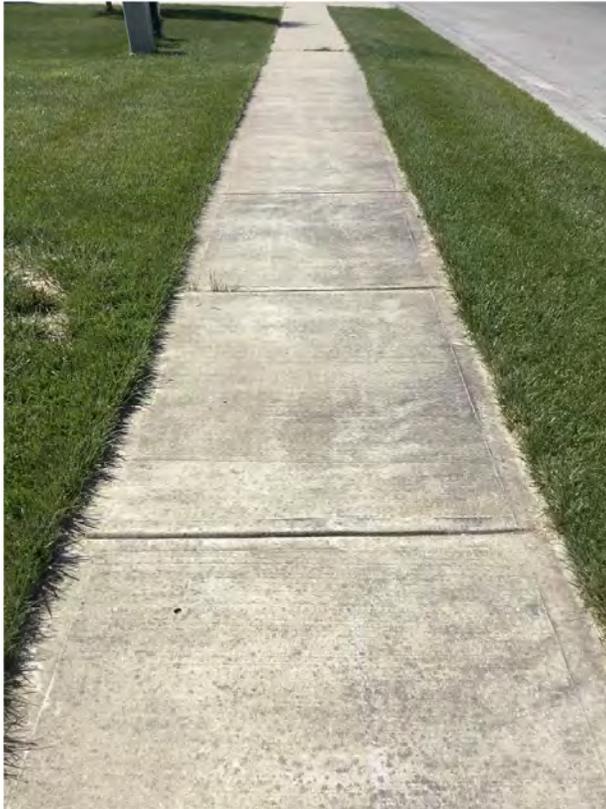
### CONCRETE RATING 8

VERY GOOD – More surface wear or slight defects, such as minor pop-outs, slight surface scaling, partial loss of joint sealant, or isolated meander crack. Little or no maintenance required.

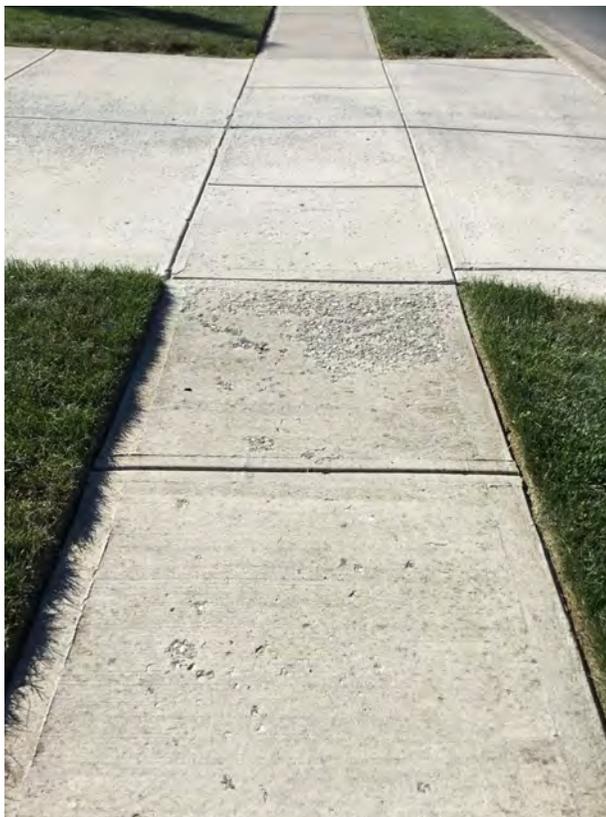
### CONCRETE RATING 7

GOOD – First signs of transverse cracking, patching, or repair. More extensive pop-outs or scaling. Some heaving or settlement. Sidewalk may appear unsightly, but is still functional. May require some routine maintenance.

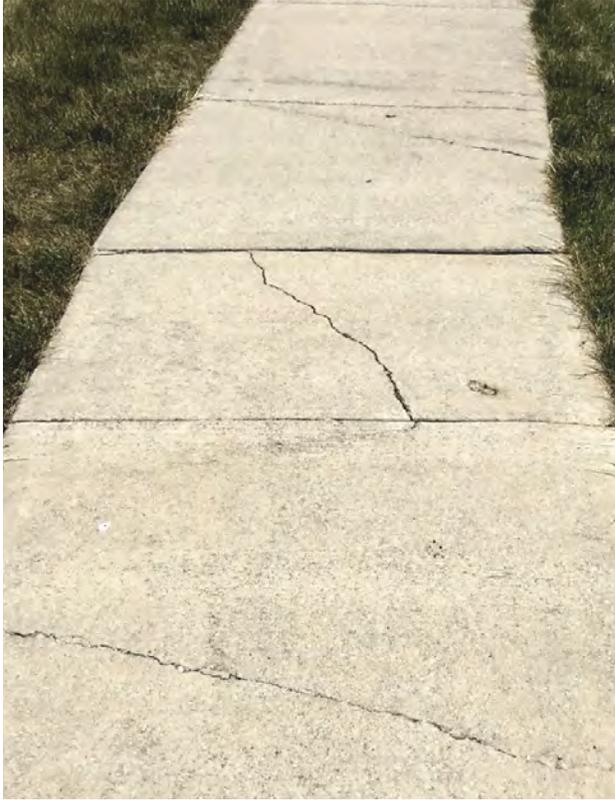
## CONCRETE RATING 6

GOOD – First signs of cracking  
More frequent transverse cracks. Open joints and cracks (1/4").  
Moderate scaling. Functionality might be a hindrance to some pedestrians.  
Joint and crack sealing and other routine maintenance may be needed.

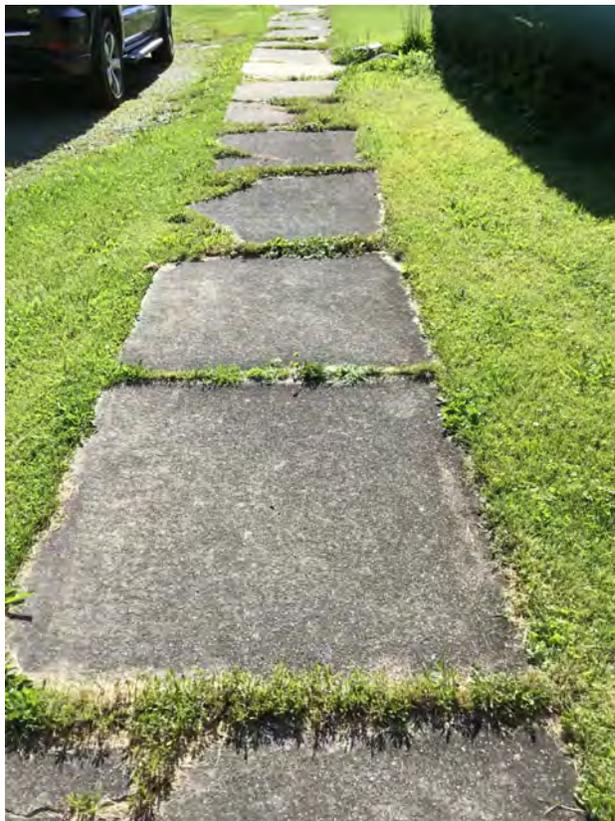
## CONCRETE RATING 5

FAIR – First signs of joint or crack spalling or faulting. Multiple cracks at corners and/or broken pieces. Functionality might be a hindrance to pedestrians. Surface texturing repairs, partial depth patching, joint repairs, or panel replacement may be needed.  
Vegetation starting to grow through cracks.

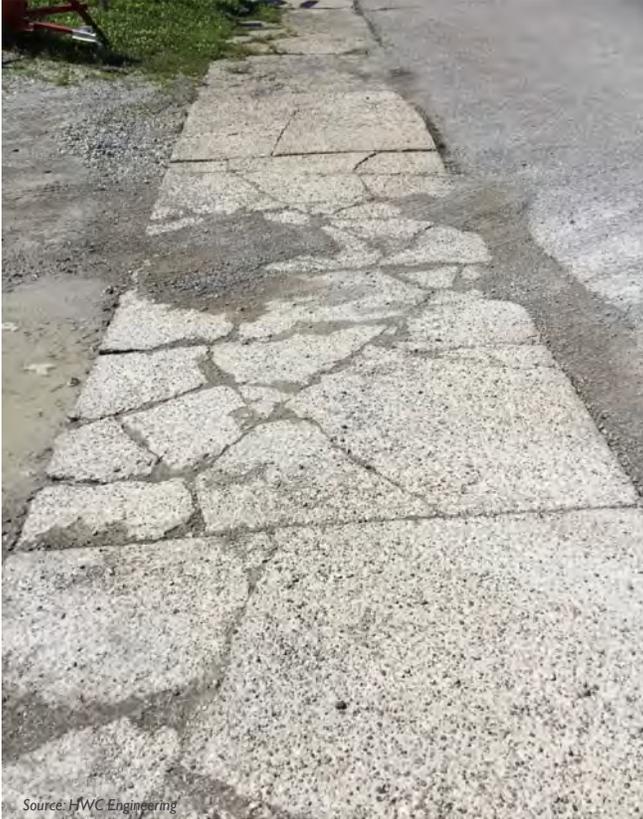
#### CONCRETE RATING 4

FAIR – Significant signs of joint or crack spalling or faulting. Multiple cracks at corners and broken pieces. Not easily navigated by pedestrians. Extensive surface texturing repairs, crack repairs, or panel replacement may be needed.

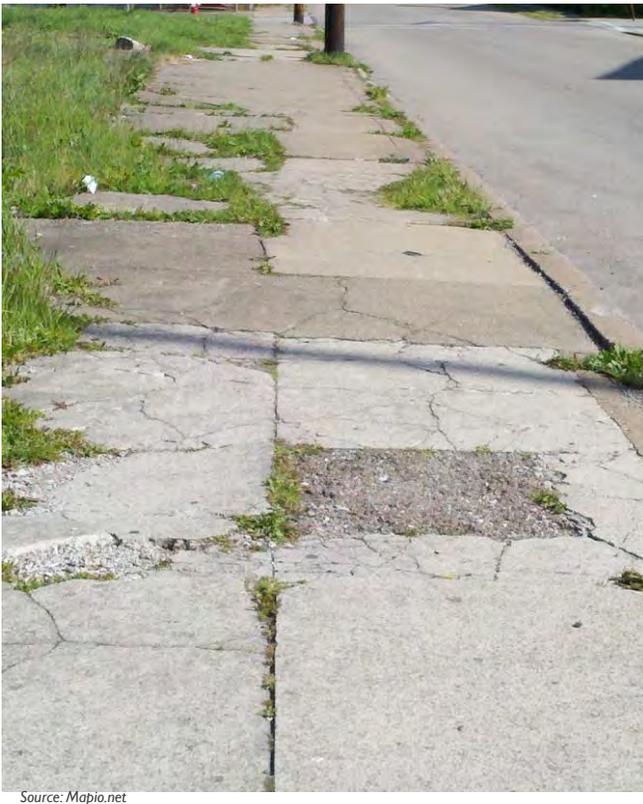
#### CONCRETE RATING 3

POOR – Severe joint or crack spalling or faulting. Most joints and cracks are open. Significant hindrance to pedestrians. Multiple panel replacement may be needed.

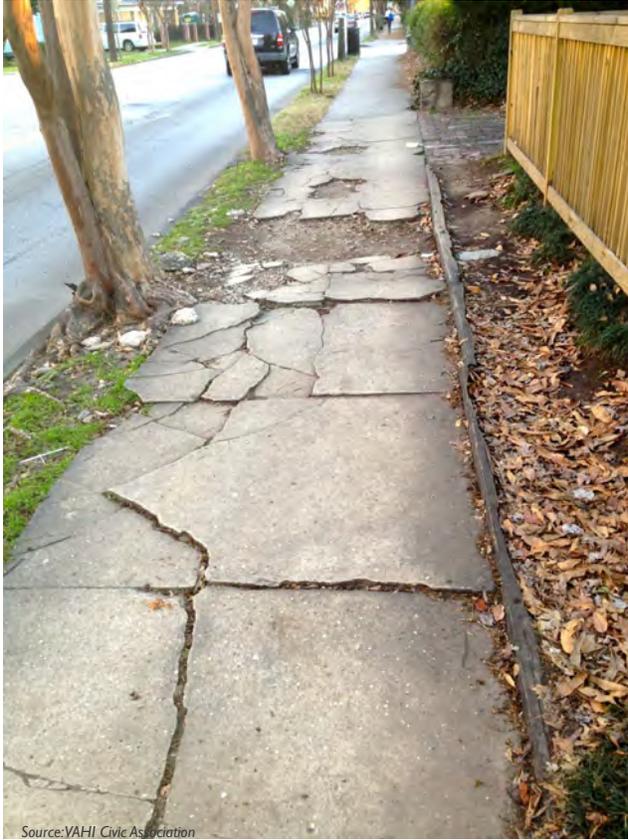
## CONCRETE RATING 2

VERY POOR – Severe deterioration and extensive joint failure. Not functional for most users. Pavement reconstruction necessary.
