Road Safety Audit

County Road 250 E and County Road 430 S

Area Plan Commission of Tippecanoe County

July 2015

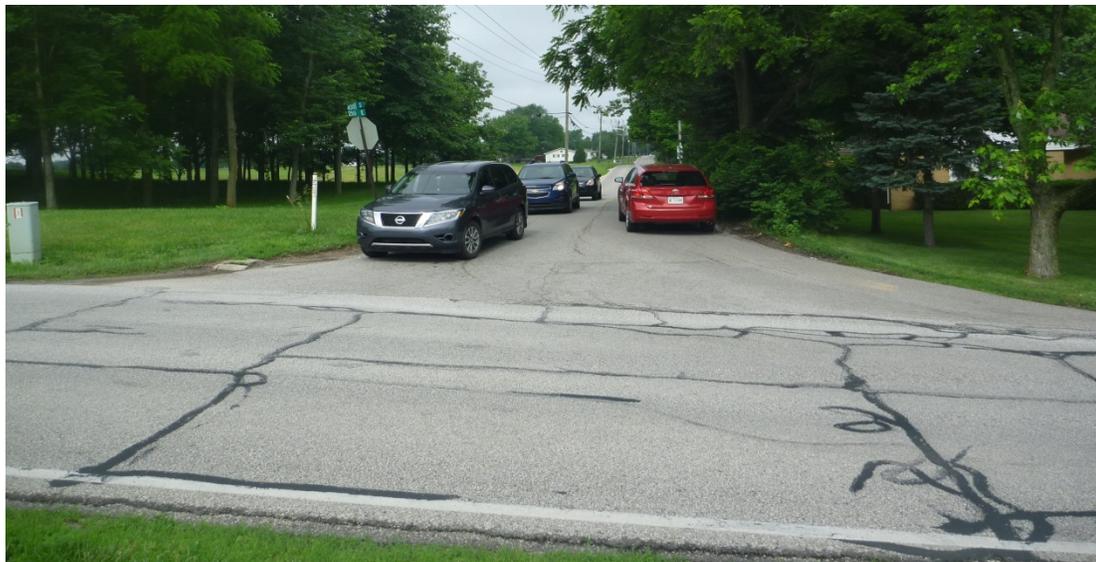
CR 430 S is a two lane rural road functionally classified as a Local road with a “good” pavement condition (67). There are two 10.5’ lanes with less than 1’ earth/gravel shoulders. There are drainage issues and an old headwall at the intersection. The land gently undulates down in elevation from west to east. Land use is residential along the road frontages but in agricultural production behind the homes.

Looking west onto CR 430S

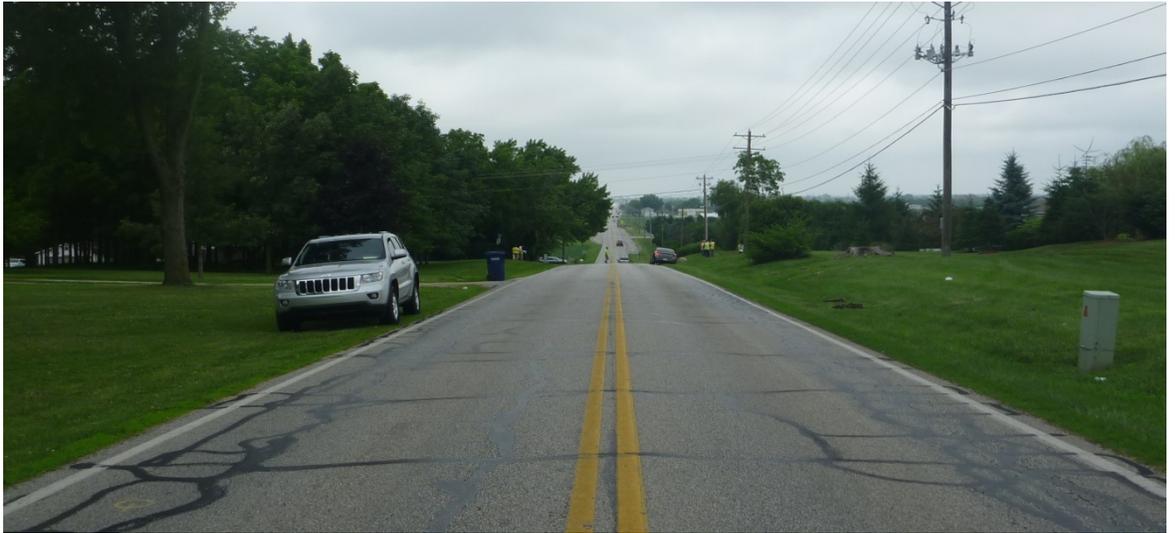
Sight distance is inadequate on the south leg of the intersection because of a rise in the elevation of the road. North bound drivers don't see the intersection until they crest and start to descend the hill. The rear end and run off the road (to avoid the left turning vehicles) crashes are a direct result of the inadequate sight distance. Speeds are high with the 85th percentile at 49 mph; however, the speed limits were lowered in the area several years ago in an attempt to reduce crashes. Wet pavements contributed to 75% of the crashes involving two vehicles. The road width, shoulder width and intersection radius do not meet current standards. There is a driveway on the north side of the intersection just 55' from the intersection.

Hill on the south leg of the Intersection

Greater intersection awareness is needed for north bound vehicles because of inadequate sight distance which is caused by a hill that obstructs the view of the intersection. Advanced intersection signing on the south leg is recommended to provide greater awareness of the approaching intersection.

To address the rear end crashes the intersection should be reconstructed. The hill on the south approach should be removed to improve sight distance and a passing blister should be constructed on the east side of the intersection. The lane and minimal shoulder widths should be widened to current standards and the new pavement should be a high friction surface to address the slippery pavement crash history. The recently completed Lafayette Trail Master Plan recommends a multi-use trail on this section of CR 250E and provisions for the trail should be included in any reconstruction.

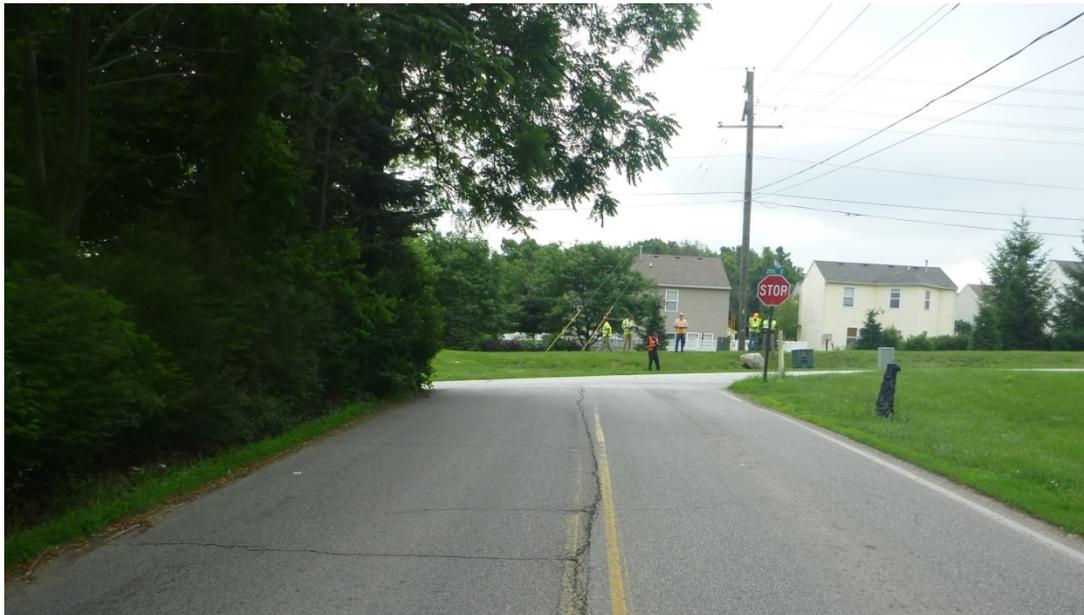
Crash history shows two patterns: a right angle pattern and disregarding the Stop sign. A relatively high proportion of crashes occurred in icy conditions. Sight distance to the north and particularly to the south is obstructed by vegetation. There is a slight dip and road undulation just prior to the intersection, there is no stop bar and again both the road width, shoulder width and intersection radius do not meet current standards. Speeds on the intersection approach seemed high and the intersection seems to come up quickly for drivers.

Sight distance obstruction on the north west corner

Greater intersection awareness is needed for east bound vehicles. This can be accomplished with the installation of advanced intersection signing, possibly a stop bar, a larger Stop sign and a double arrow on the far side of the intersection. Vegetation on the west side of the intersection should be trimmed, particularly the northwest corner where it may be in the public right-of-way.

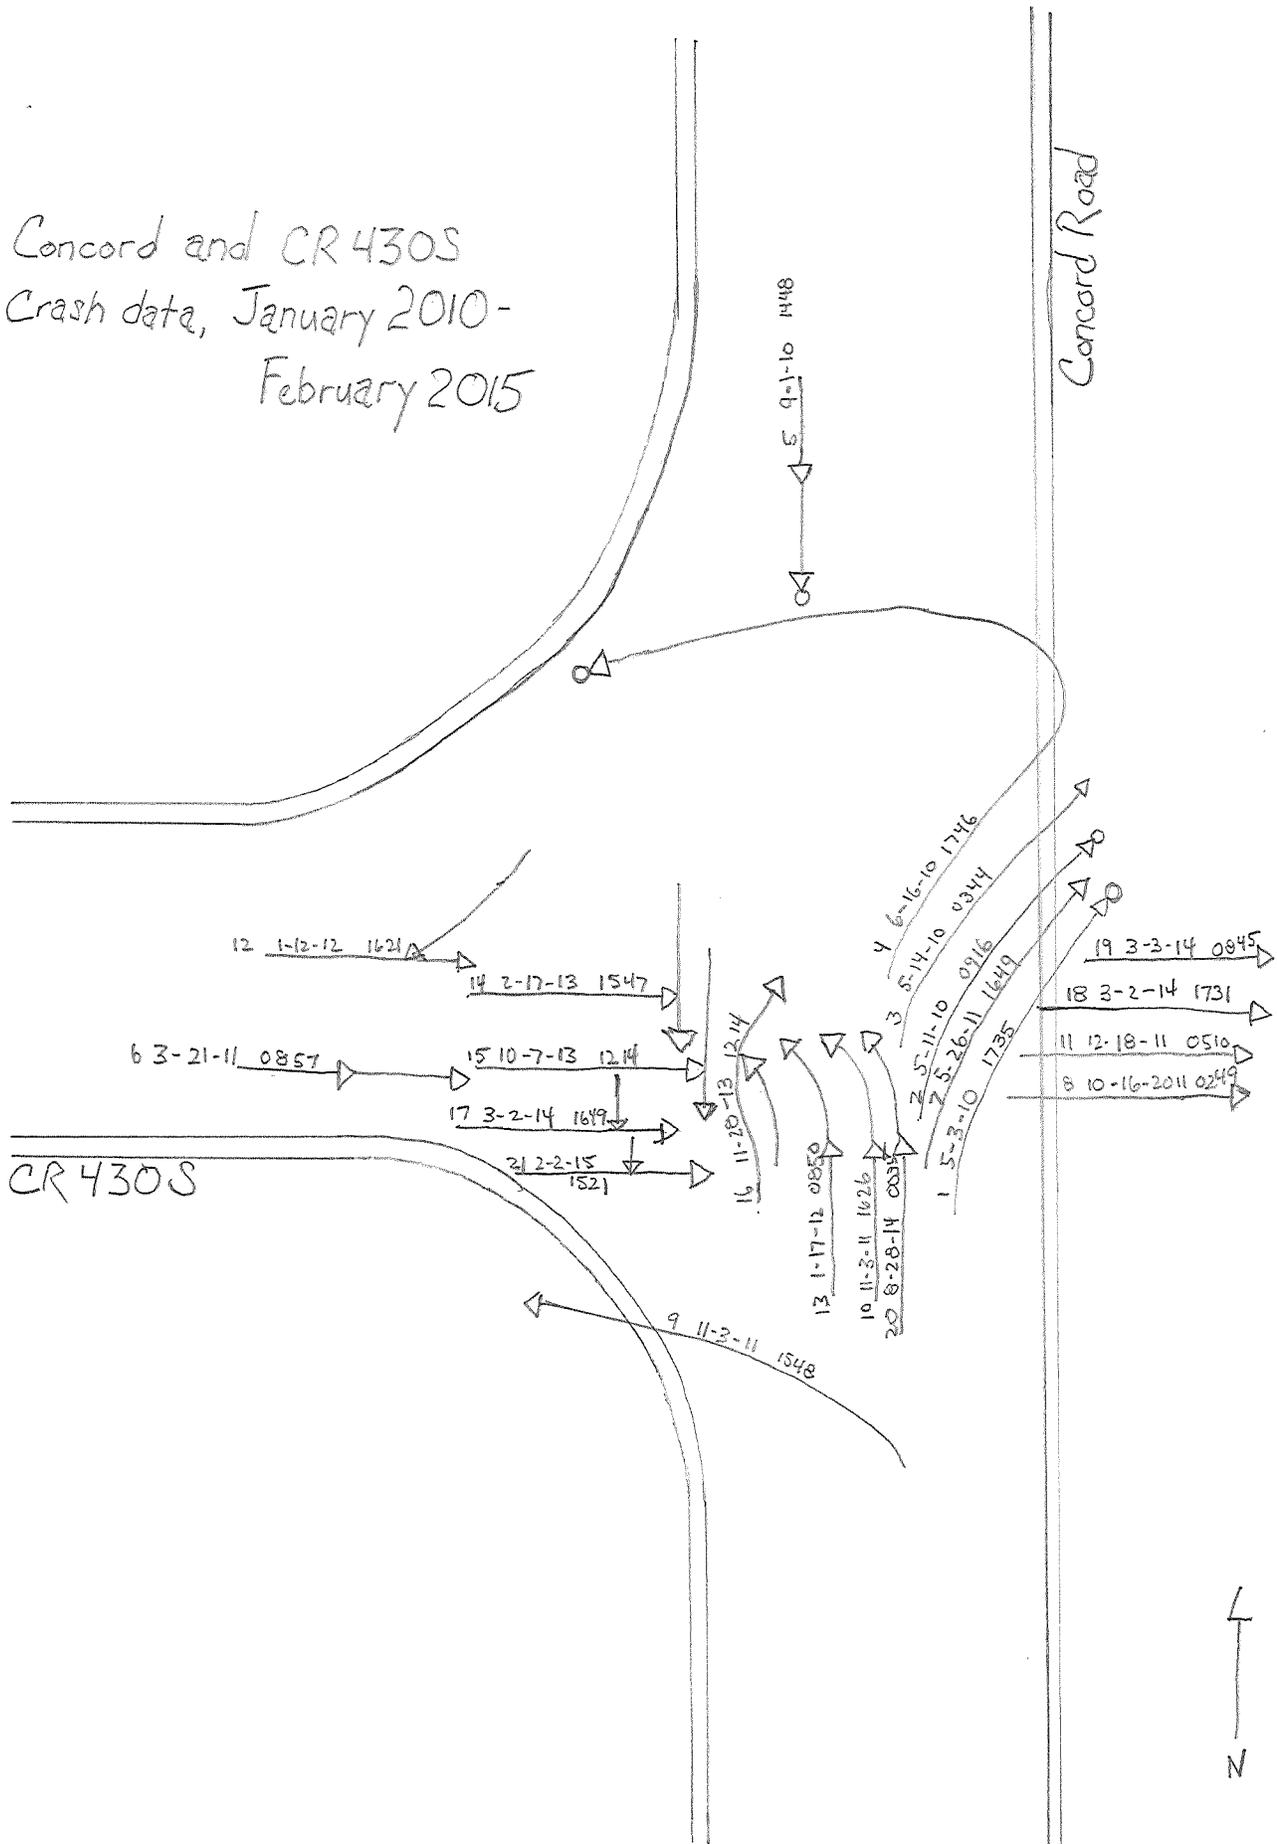
Concord and CR 430S
 Crash data, January 2010-
 February 2015

The collision diagram shows the greatest number (nine) occurred when a vehicle was traveling northbound and did not see the secondary vehicle waiting to turn left onto CR 430S. Of those nine, three involved an injury. Four resulted in the vehicle rear-ending the waiting vehicle and the remaining five involved the vehicle running off the road. Four of the five Right Angle crashes involved vehicles pulling out from CR 430S. Two of those four were due to icy roads. The fifth crash involved a south bound turning vehicle making too wide of a turn. The other notable crash type involved vehicles traveling east on CR 430S disregarding the Stop sign. Two of those were related to icy road conditions.

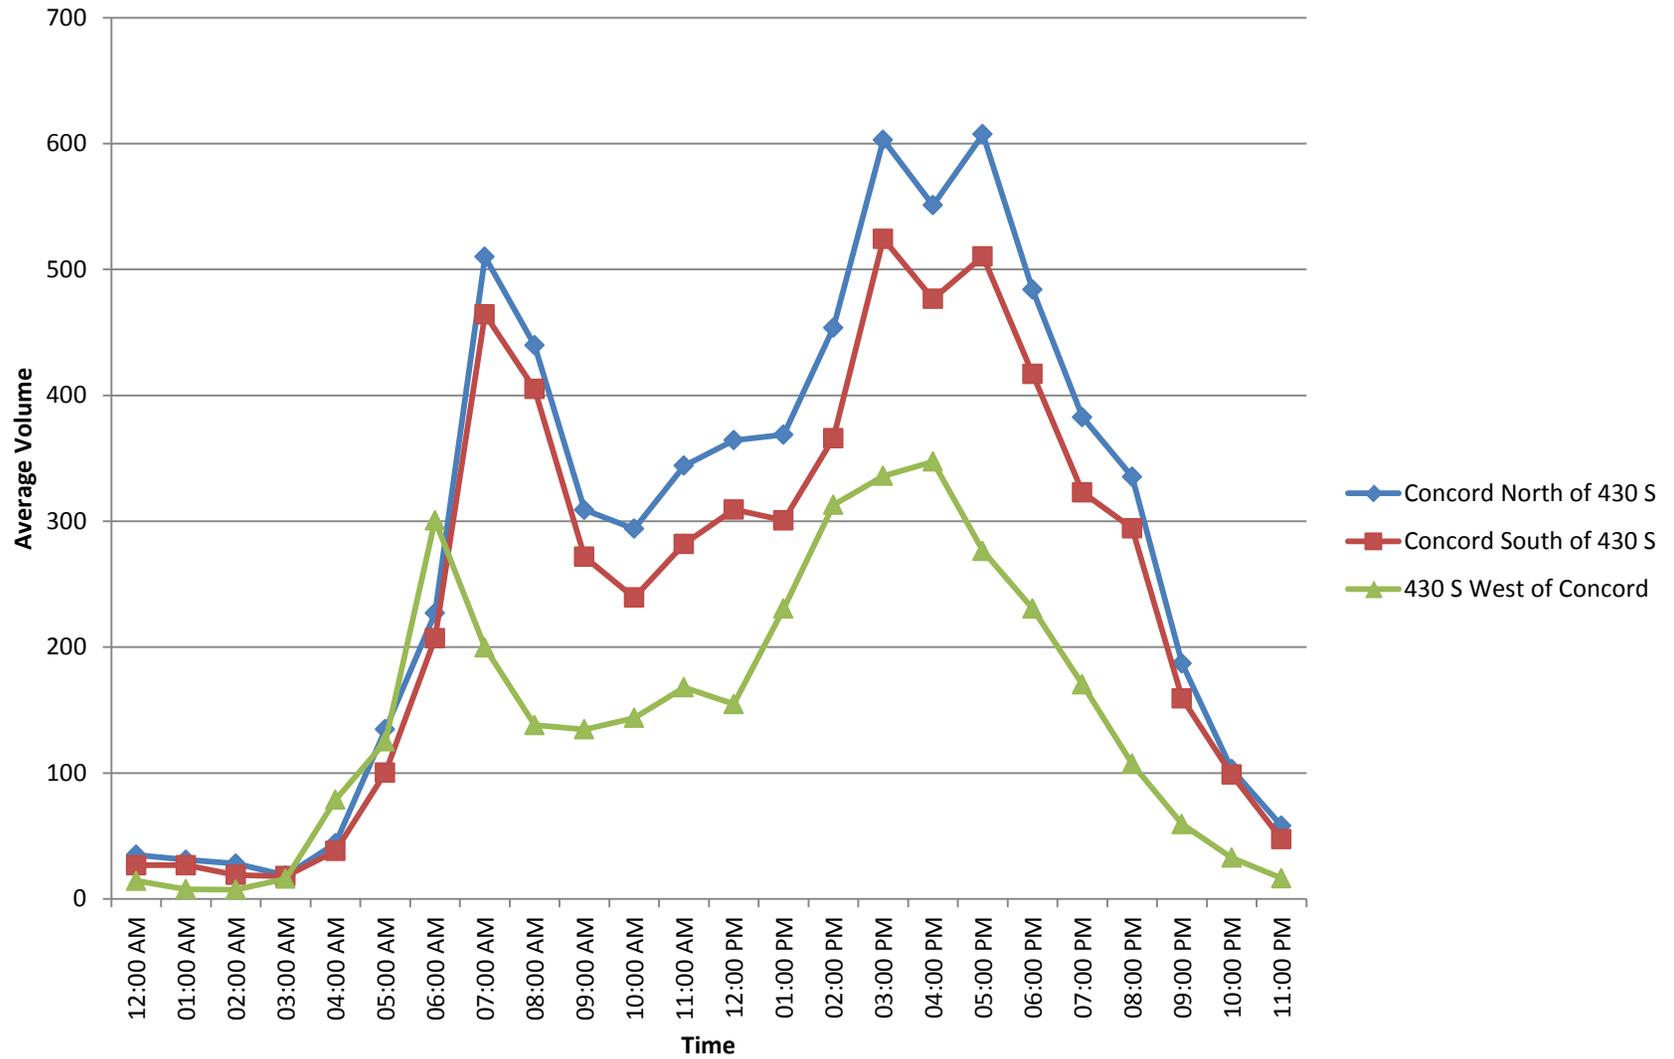
2013 Average Hourly Volume (Concord and 430 S)

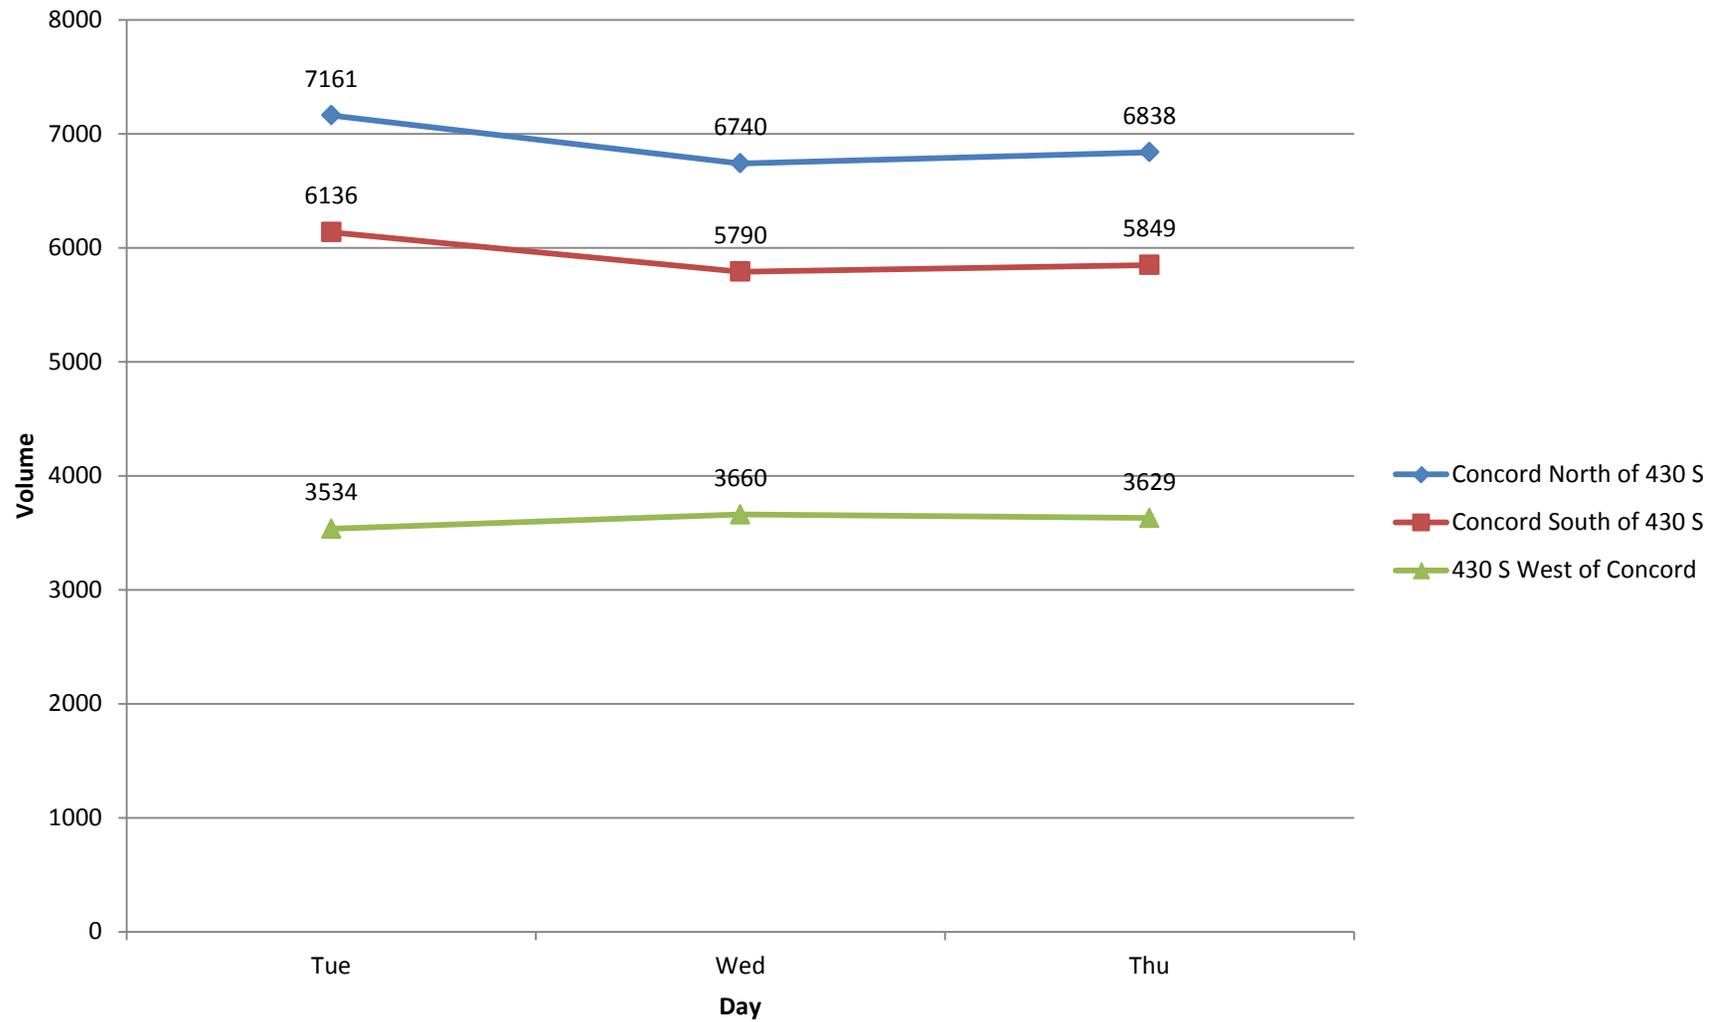
2013 Daily Counted Volumes (Concord and 430 S)

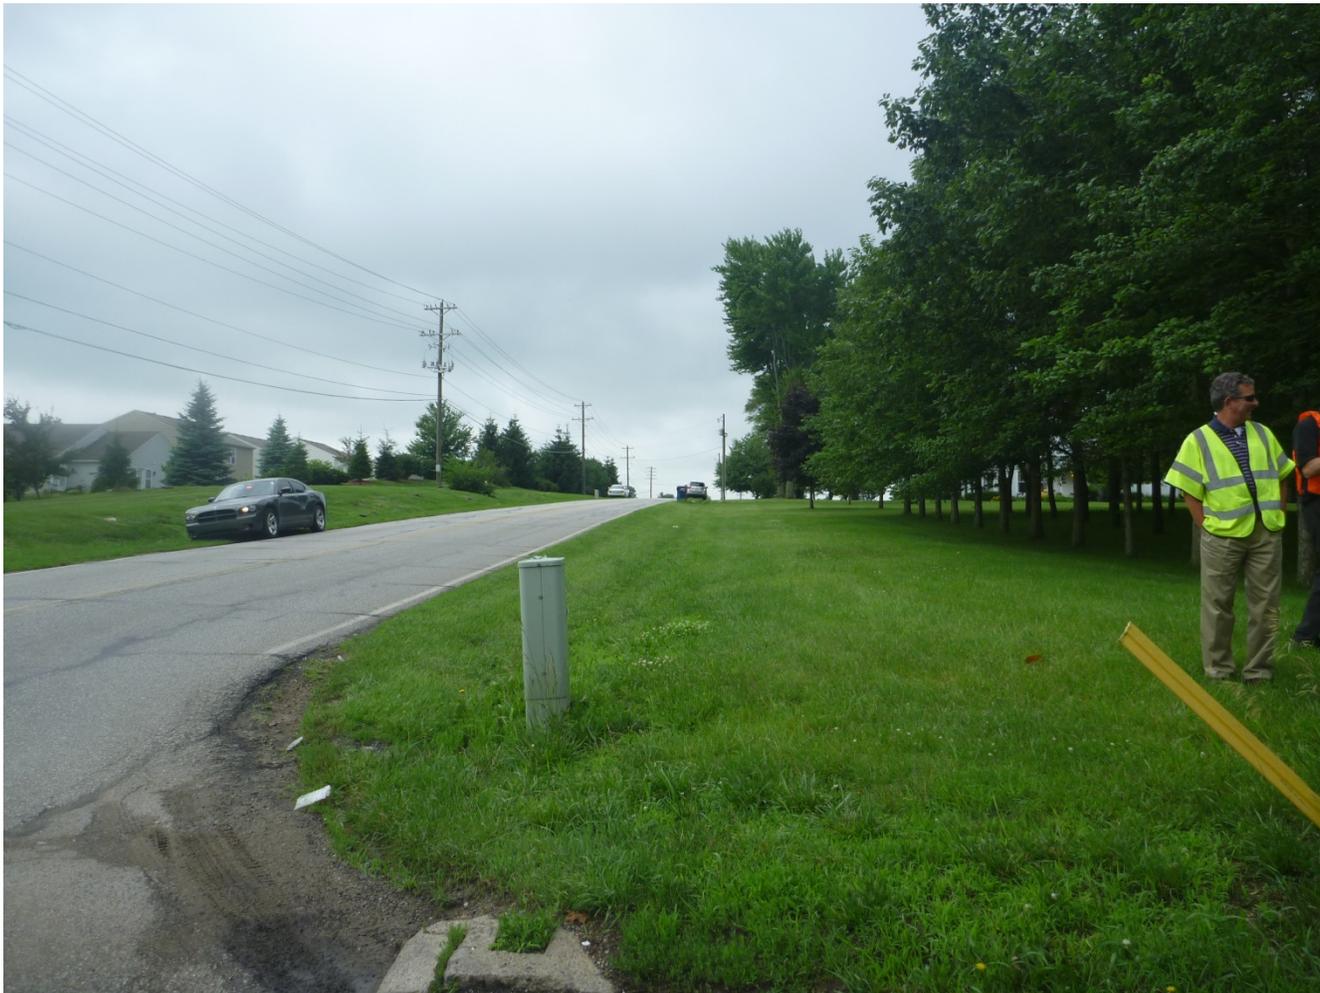
At the intersection looking north up the hill

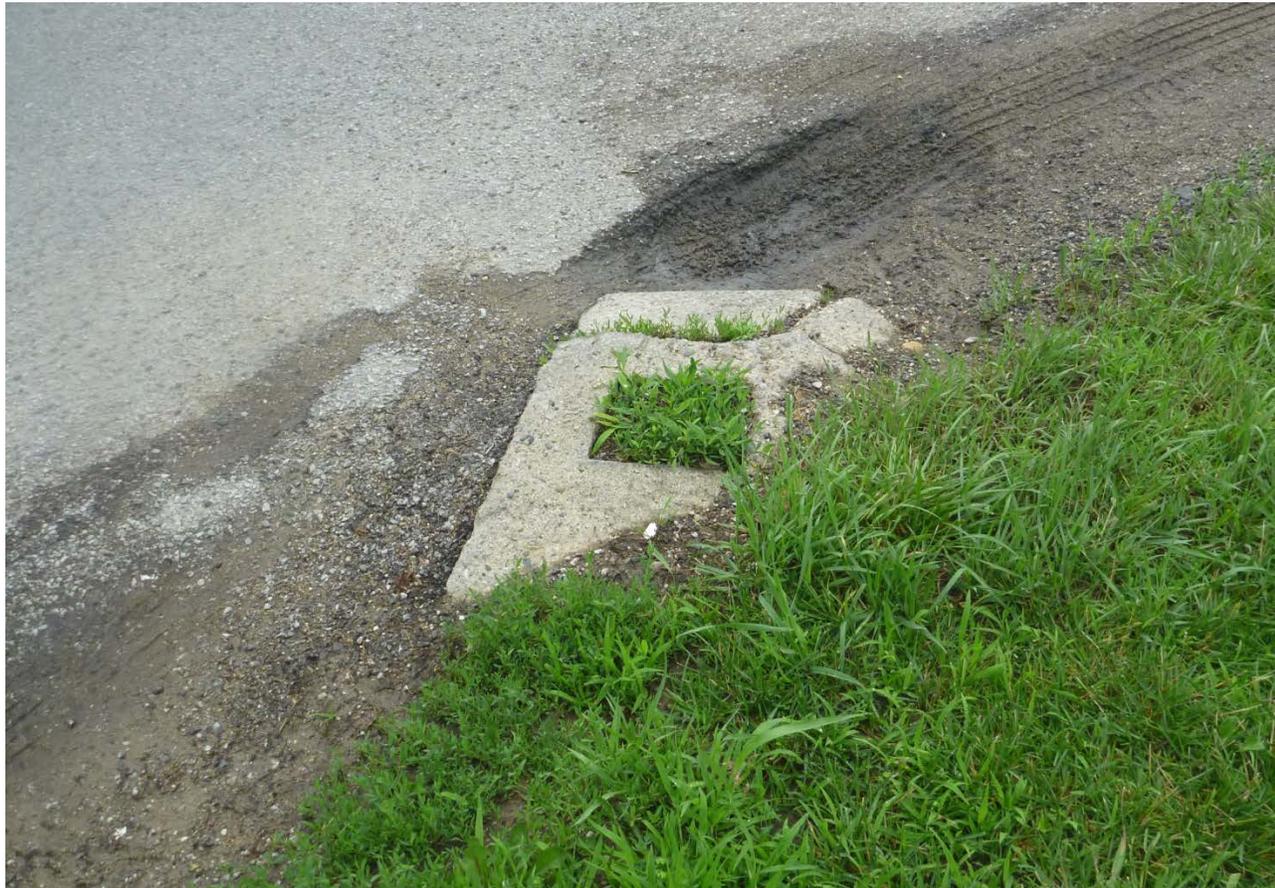
Old Headwall (southwest corner of intersection)
